ARBORICULTURAL
REPORT:

BS 5837 – 2012

TATA STEELWORKS,
PONTARDDULAIS

Project Number	J00223	
Title	Arb Report	
Document Number	J0023- Arb Report-V1.1	
Client	Walters	
Issue Date	26-May-23	
Prepared by:	David Price	26-May-23

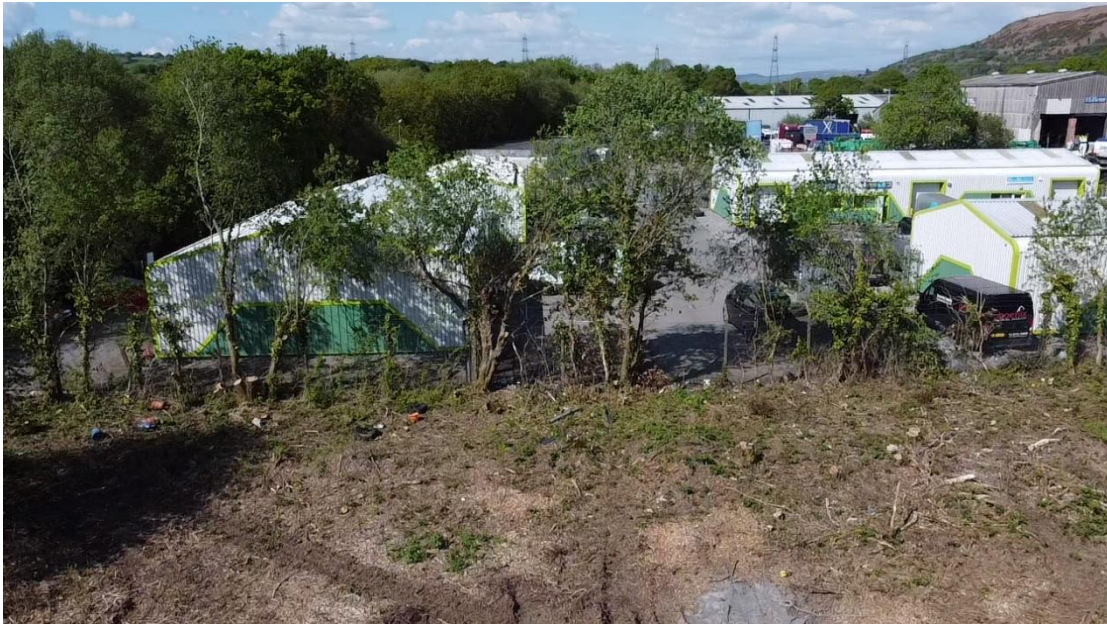
G1	Cat C1	Area of scrub along railway embankment. Species composition is dominated by young birch, willow, oak, and ash with an average height of 8m. The understorey is dominated by gorse, buddleia, and bramble.
G2	Cat C1	Small area of scrub, with young birch, willow, oak with an average height of 8m. The understorey is dominated by gorse and bramble, partially behind fence
G3	Cat C1	Small area of overgrown and unmanaged willow scrub.
G4	Cat C1	Small area of hawthorn scrub on boundary.
G5	Cat C1	Small group of partially felled multistem willows on site boundary, with an average height of 10m and stem diameter of 300mm. The trees have been heavily cut back and have been impacted upon by neighbouring trees. It is recommended that the trees are removed.
G6	Cat C1	Small group of partially felled multistem willows on site boundary. The trees have been heavily cut back and have been impacted upon by neighbouring trees. It is recommended that the trees are removed.

G7	Cat C1	Small group of partially felled multistem willows on site boundary, with an average height of 10m and stem diameter of 300mm. The trees have been heavily cut back and have been impacted upon by neighbouring trees. It is recommended that the trees are removed.
G8	Cat C1	Small group of partially felled multistem willows on site boundary, with an average height of 10m and stem diameter of 300mm. The trees have been heavily cut back and have been impacted upon by neighbouring trees. It is recommended that the trees are removed.
G9	Cat C1	Small area of hawthorn scrub.
G10	Cat C1	Small cluster of semi mature birch trees off site. Access and viability a constraint.
G11	Cat B1	Large, mature oak trees, with small birch, and willow and railway embankment. The trees are too far down the embankment to make an accurate assessment of size etc.
G12	Cat B1	Large mature, oak and willow trees. Trees are down the railway embankment, so access and visibility are a constraint. Evidence of Japanese knotweed.

Photo 1: Overview of G6, G7 and G8.

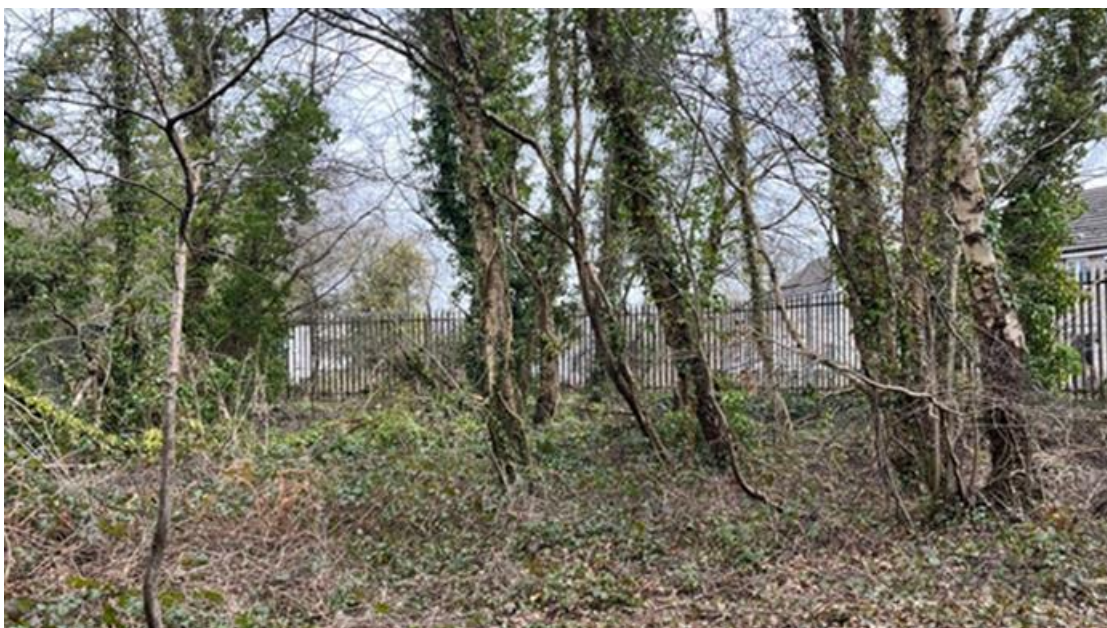
G15	Cat C1	Area of willow scrub, trees approximately 10m tall. Japanese knotweed throughout.
G16	Cat C1	Area of willow and birch scrub, trees approximately 5m tall, limited understory. Japanese knotweed present.
G17	Cat C1	Small stand of willow trees, approx. 10 m tall, low bat potential. Japanese knotweed
G18	Cat C1	Small stand of birch trees, approximately 9m tall. Japanese knotweed
G19	Cat C1	Area of overgrown willow and birch scrub, with Japanese knotweed throughout.
G20	Cat B1	Group of overgrown, scrub around pond. Species composition is dominated by mature willow, ash, and birch. There is little understorey, and there is evidence of Japanese knotweed. It is recommended that a management strategy is put together to, thin out the trees and allow the pond and the trees to be enhanced.
G21	Cat C1	Area of willow and birch scrub along railway embankment.

Photo 2: Overview of G16

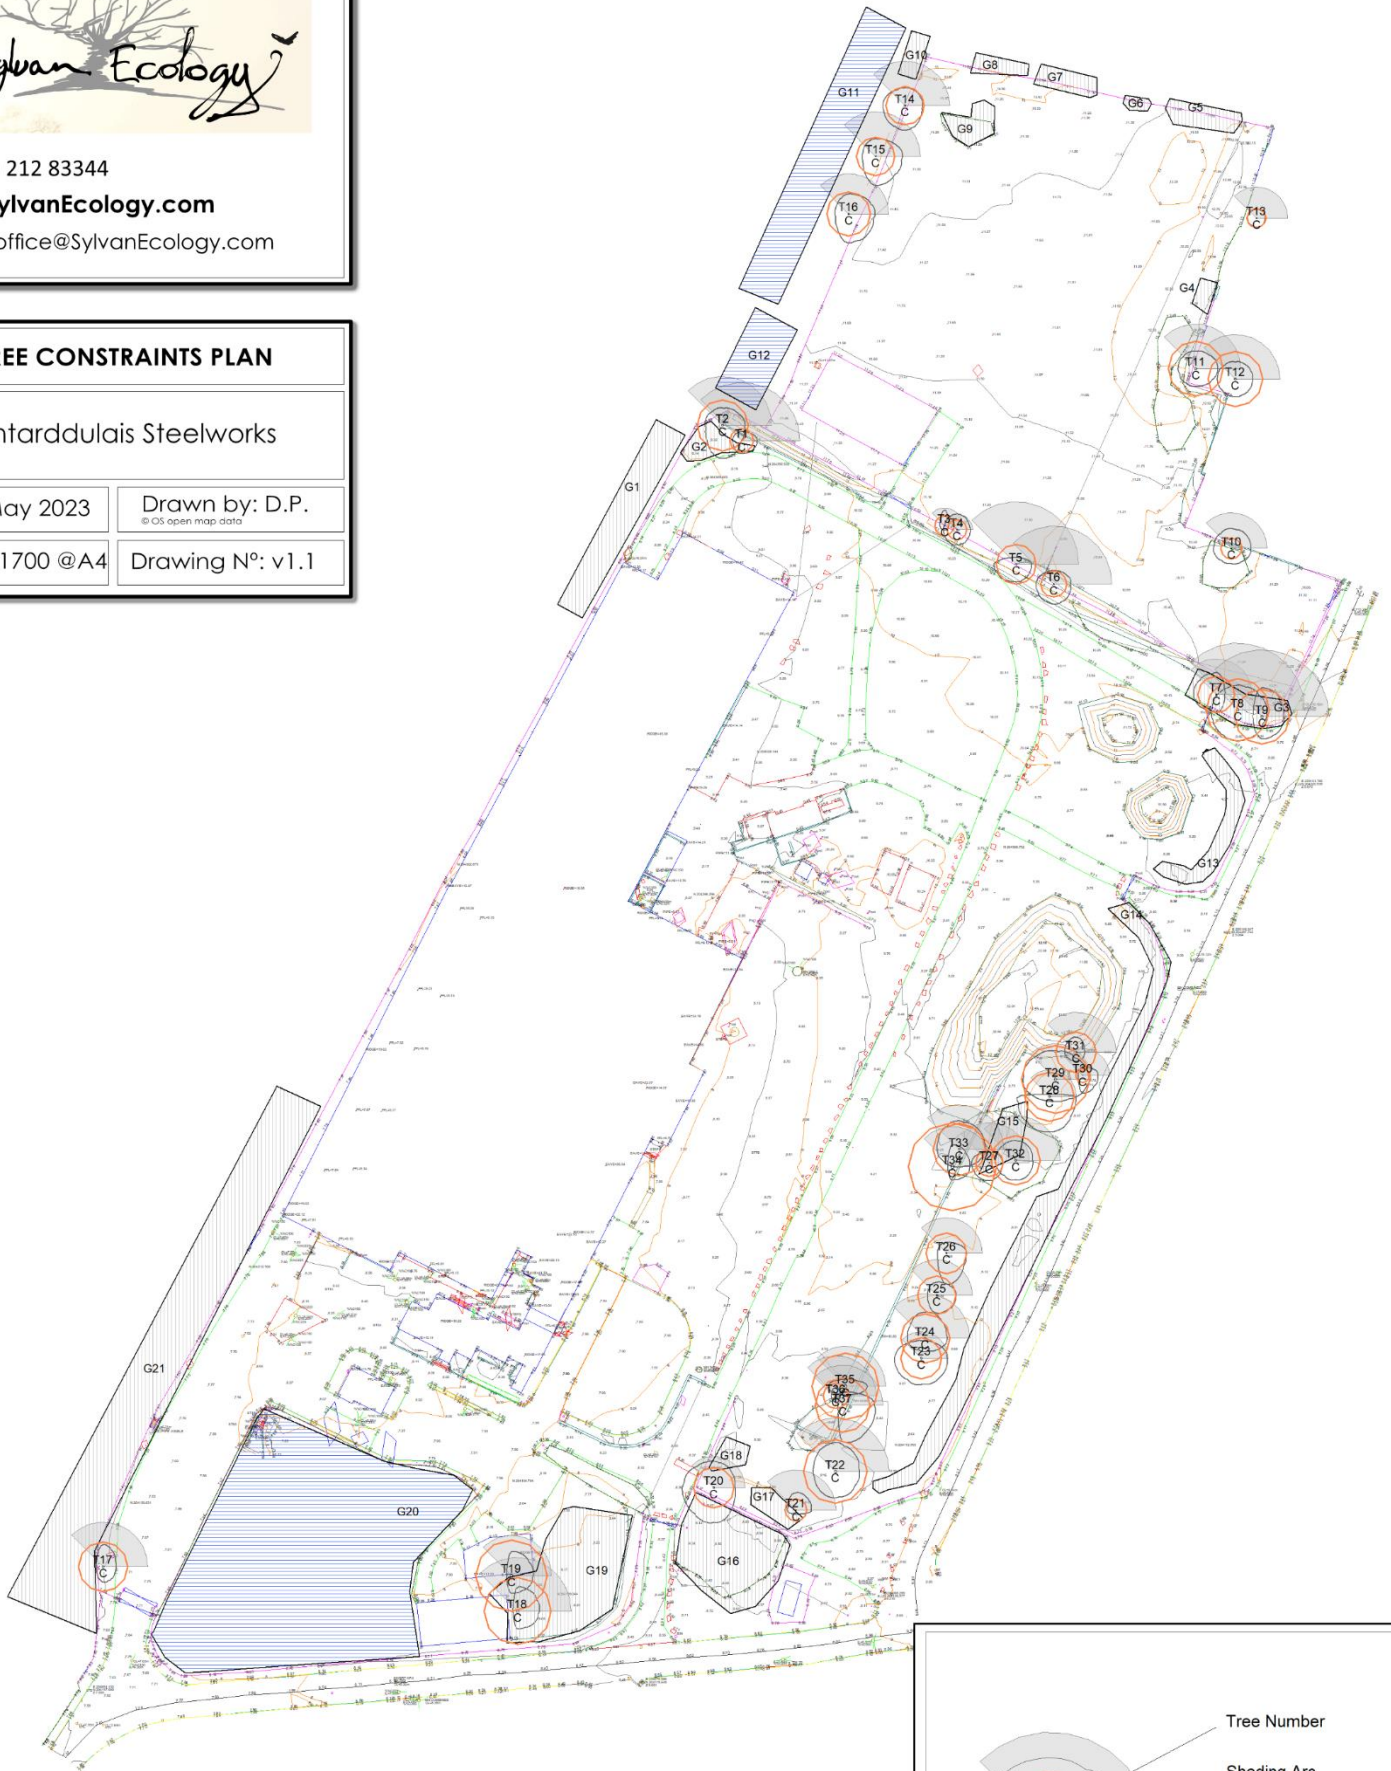
TREE CONSTRAINTS PLAN

- 3.5 The TCP attached overleaf, highlights the above and below ground constraints each tree poses to the future scheme design. The orange circle set out the RPAs, and the different coloured circled highlight the crown spread of the trees on site.
