**Former Tata Site,  
Pontarddulais**

**Archaeological  
Assessment**

Prepared by:  
**The Environmental Dimension  
Partnership Ltd**

Report Reference  
**edp8269\_r002b**

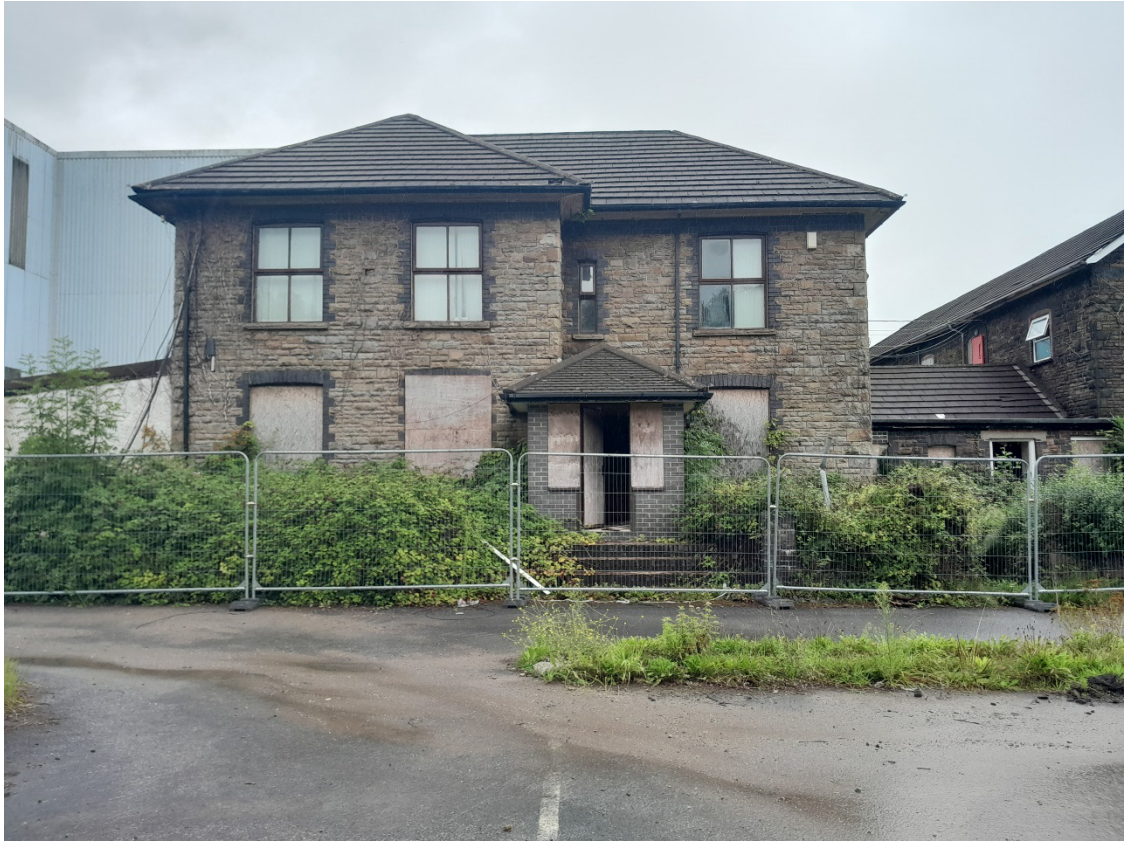
**Image EDP A1.1:** North facing view of the extant historic connecting 'L-shaped' stone-built buildings associated with the former Glamorgan Works (**GGAT01225w**) within the Site. Twentieth century renovation and alteration is visible including the modern roof, brick porchway extension, wooden window casements and adjoining lean-to extension on the west side of the building.

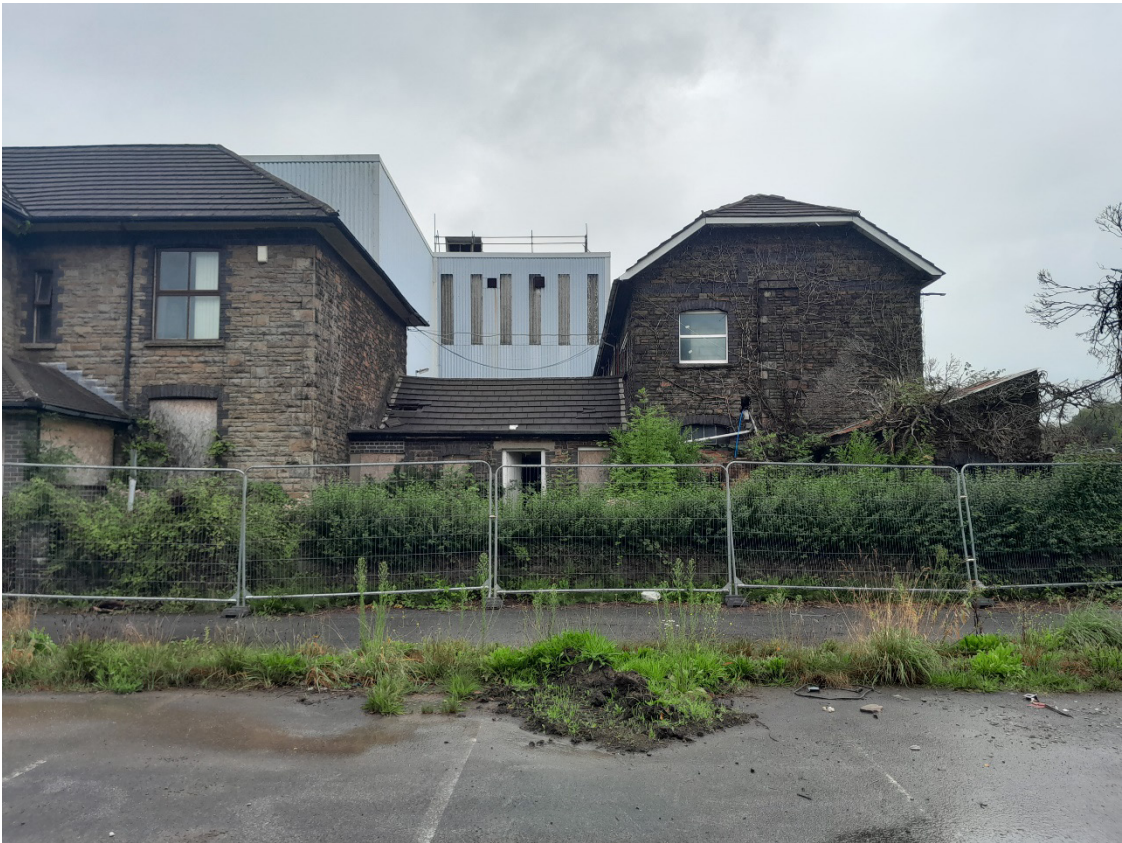
**Image EDP A1.2:** North facing view of the extant historic connecting 'L-shaped' stone-built buildings associated with the former Glamorgan Works (**GGAT01225w**) within the Site. Twentieth century renovation and alteration is visible including the modern roof, wooden and white PVC window casements and altered doorways.

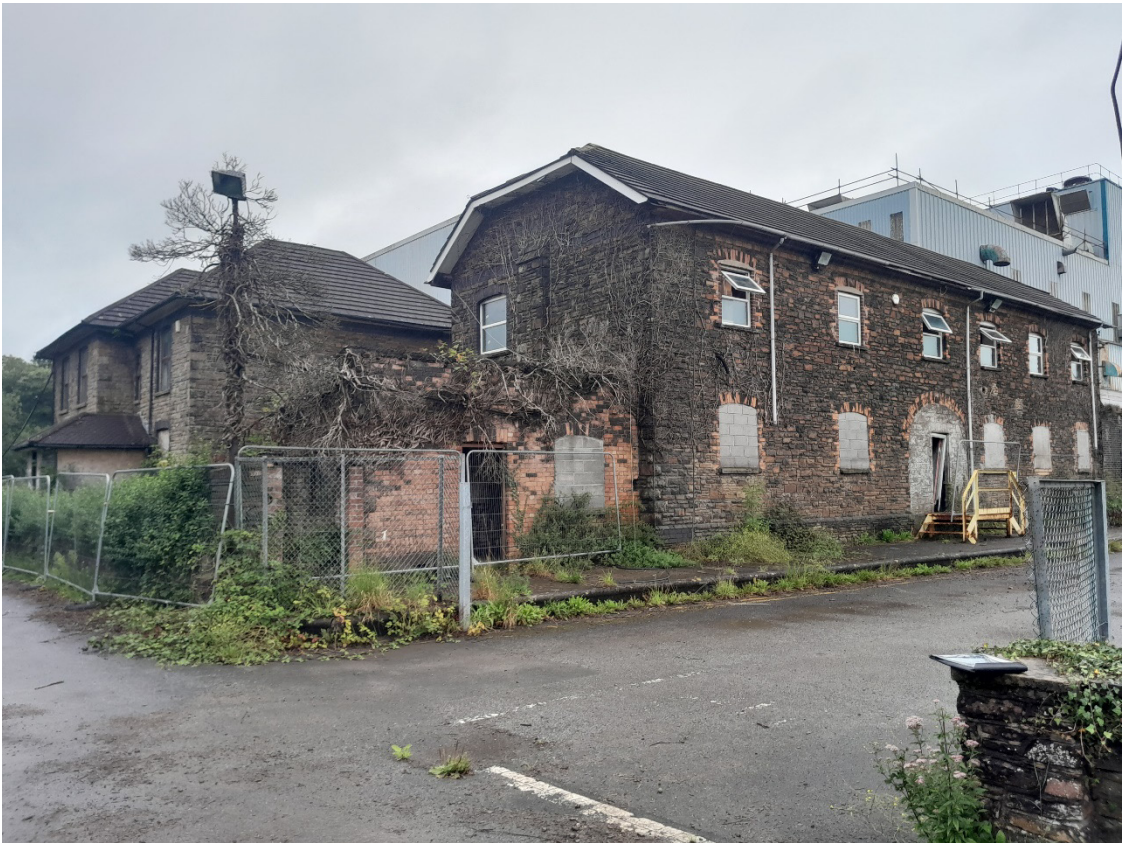
**Image EDP A1.3:** North-west facing view of the extant historic connecting 'L-shaped' stone-built buildings associated with the former Glamorgan Works (**GGAT01225w**) within the Site. Twentieth century renovation and alteration is visible including the modern roof, white PVC window casements, altered doorway and red brick building extension.

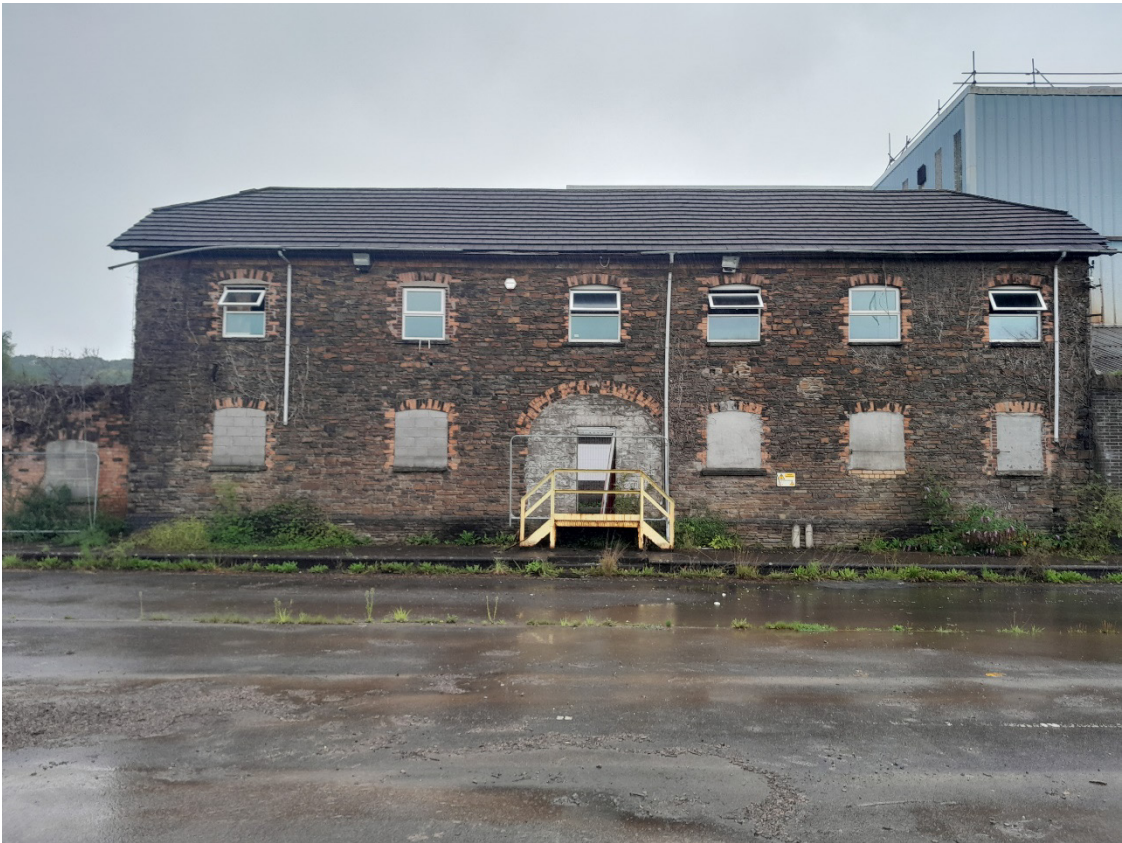
**Image EDP A1.4:** West facing view of the extant historic connecting 'L-shaped' stone-built buildings associated with the former Glamorgan Works (**GGAT01225w**) within the Site. Twentieth century renovation and alteration is visible including the modern roof, white PVC window casements, altered doorway and red brick building extension on the south side of the building.

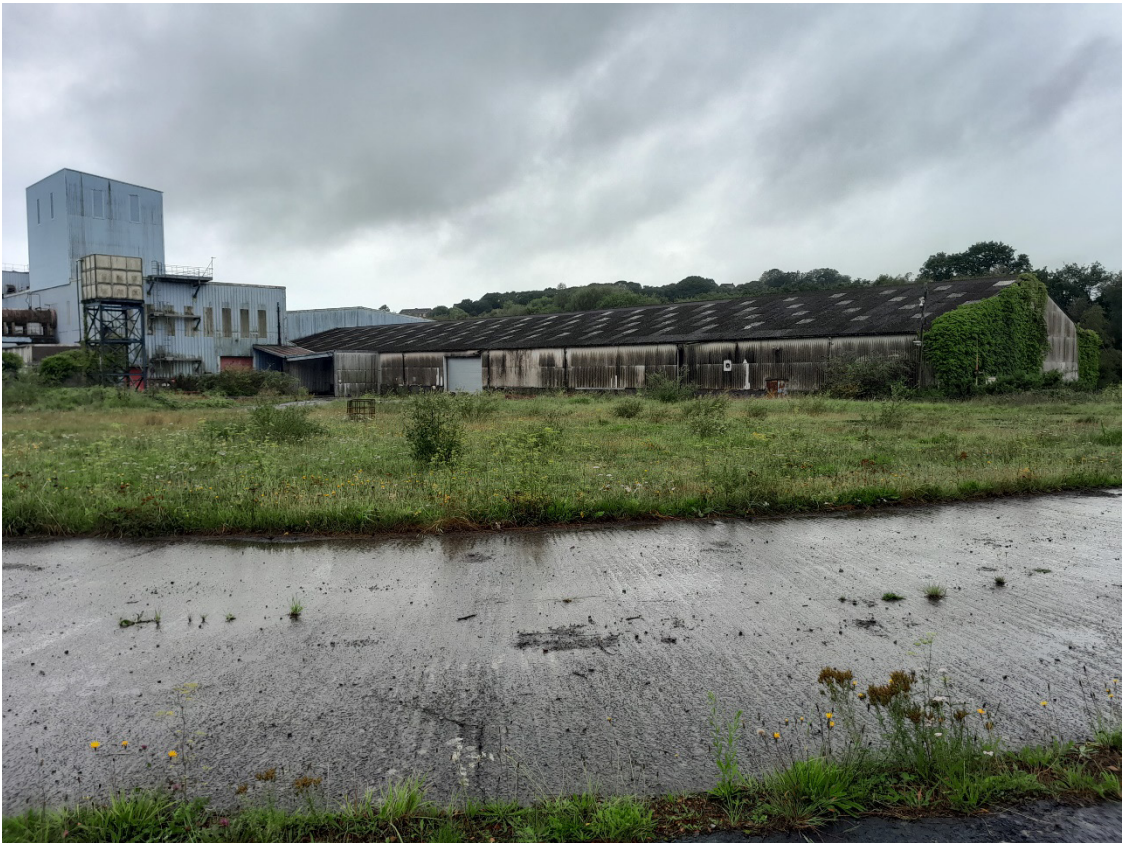
**Image EDP A1.5:** South-west facing view of the 1960s constructed warehouse building to the north end of the building complex within the Site.

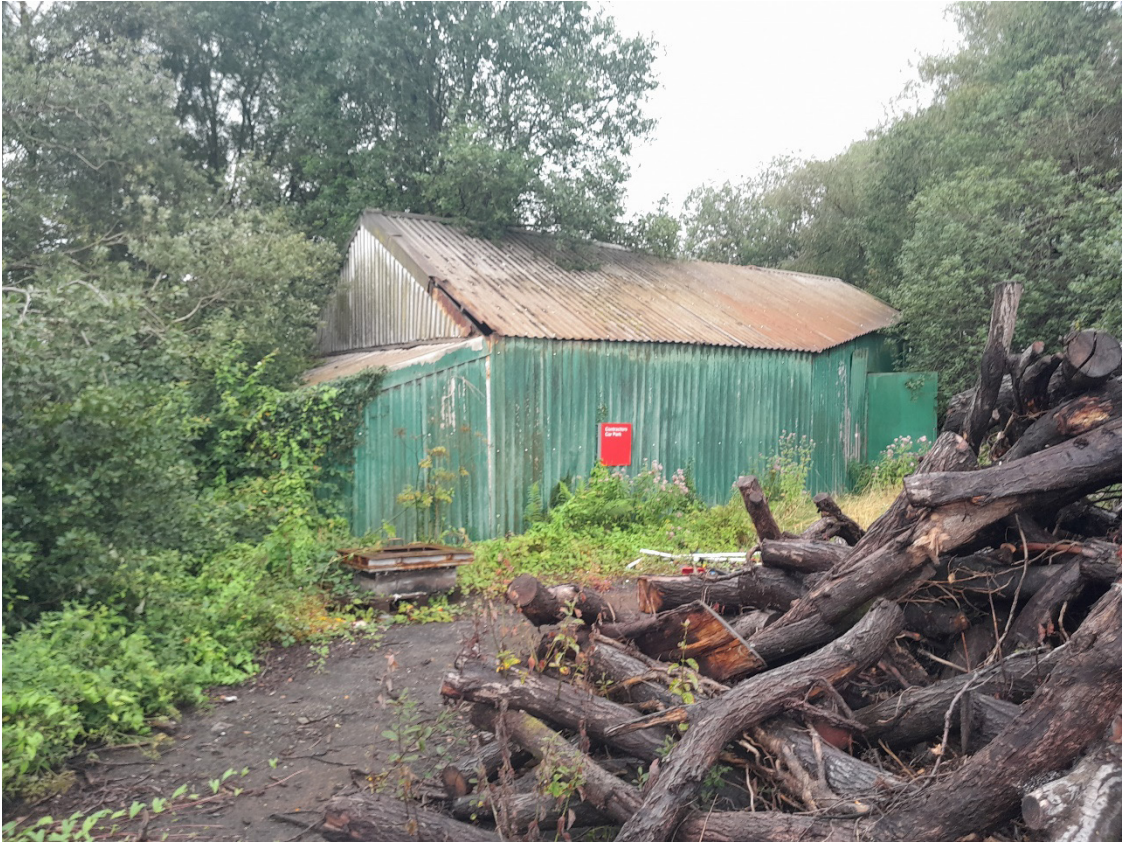
**Image EDP A1.6:** South facing view of the identified 1960s-1970s corrugated steel shed (1/2) within the south end of the Site.

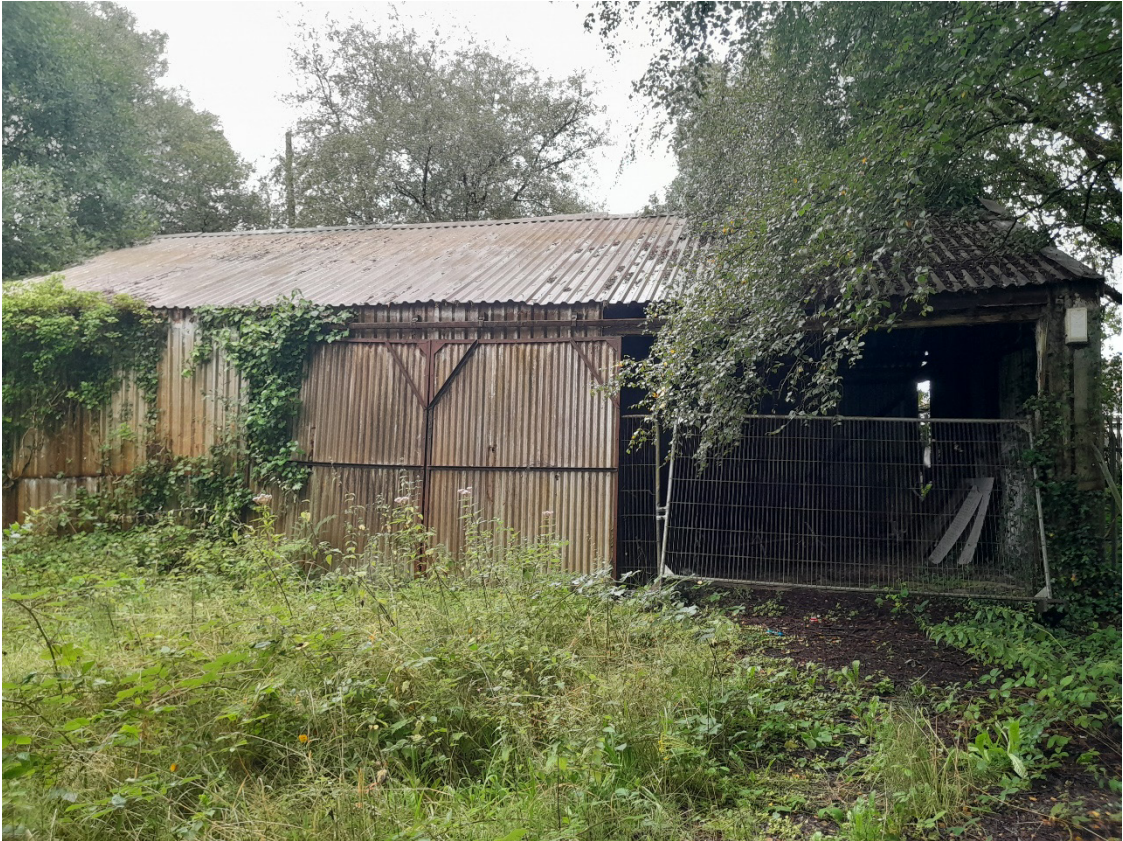
**Image EDP A1.7:** South facing view of the identified 1960s-1970s corrugated steel shed (2/2) within the south end of the Site.

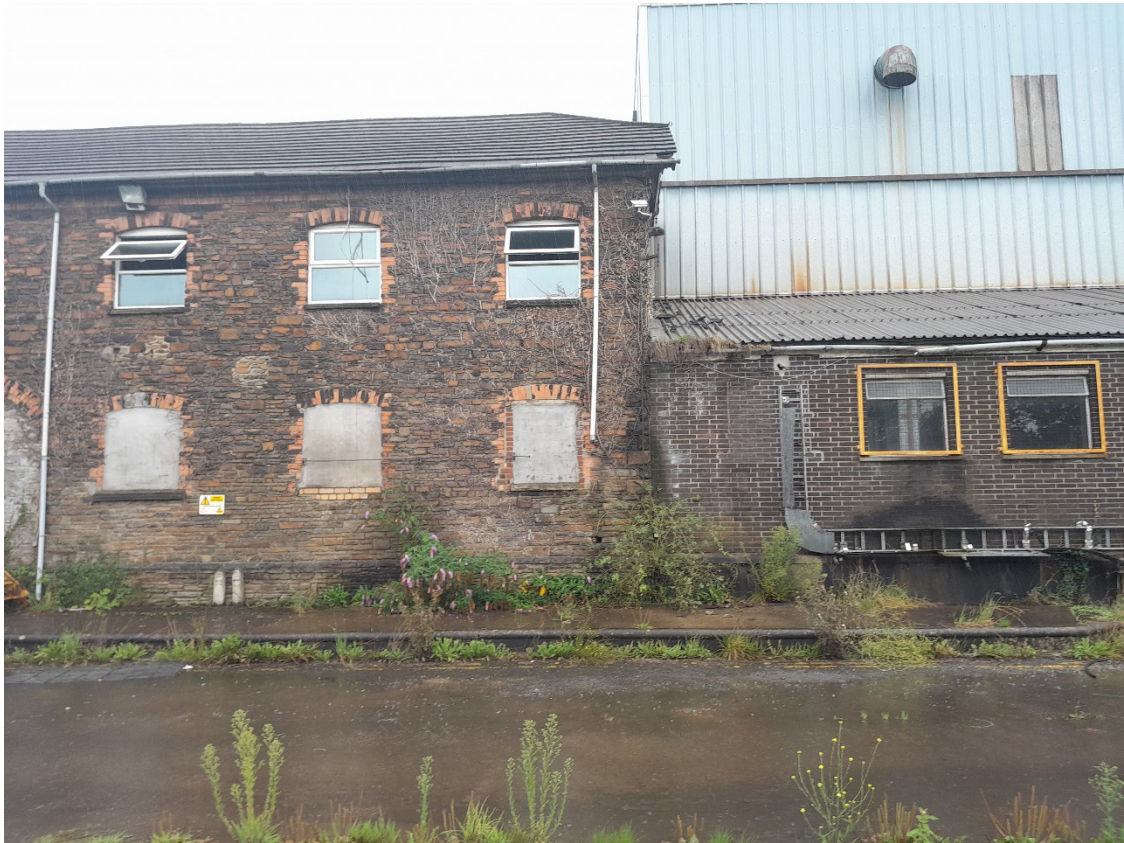
**Image EDP A1.12:** West facing view of the identified north-south orientated 1870s historic stone-built building (left) and adjoining modern 1972-1992 built post-Glamorgan Works building (right). Modern building is adjoined at edge of building, i.e. dressing quoin stones still present on historic building, showing no sign of the integration of walls.

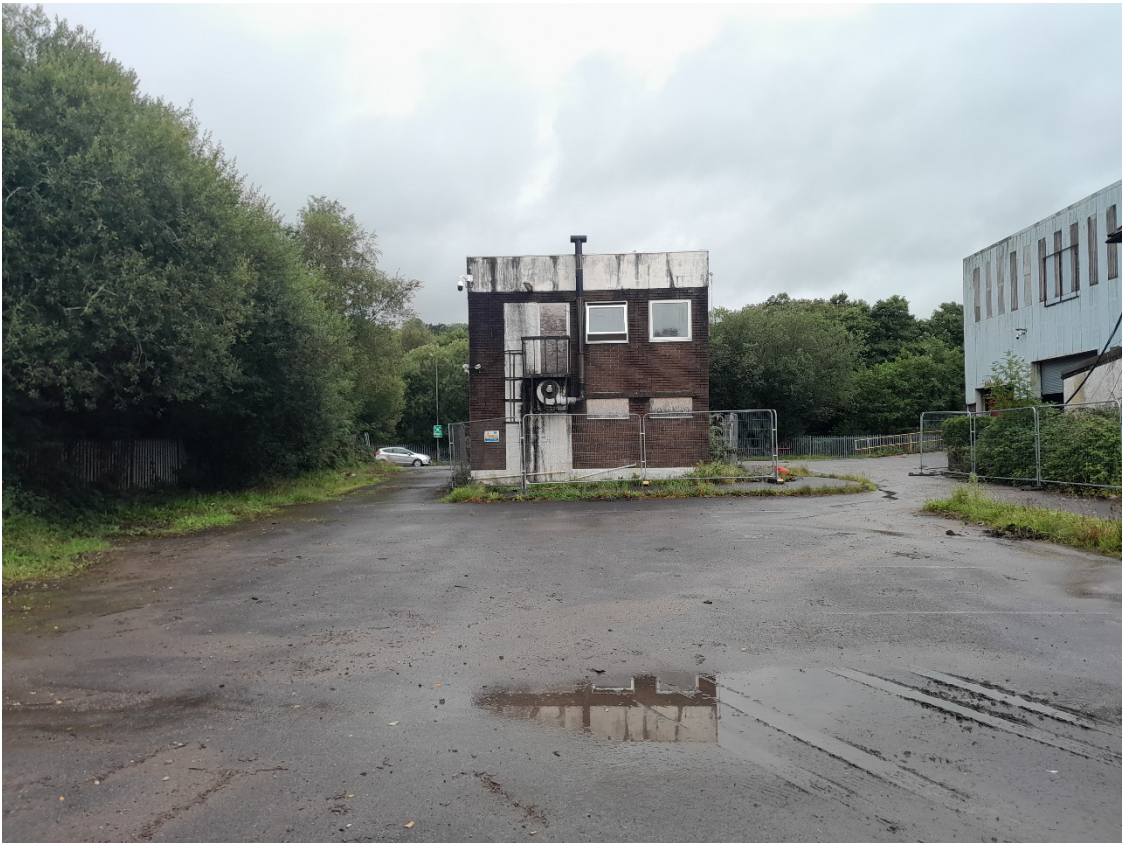
**Image EDP A1.13:** West facing view of extant outbuilding to the south of the main building complex within the Site. The brown brick and flat roof structure most likely dates between 1972-1992, alongside the majority of the extant building complex within the Site.

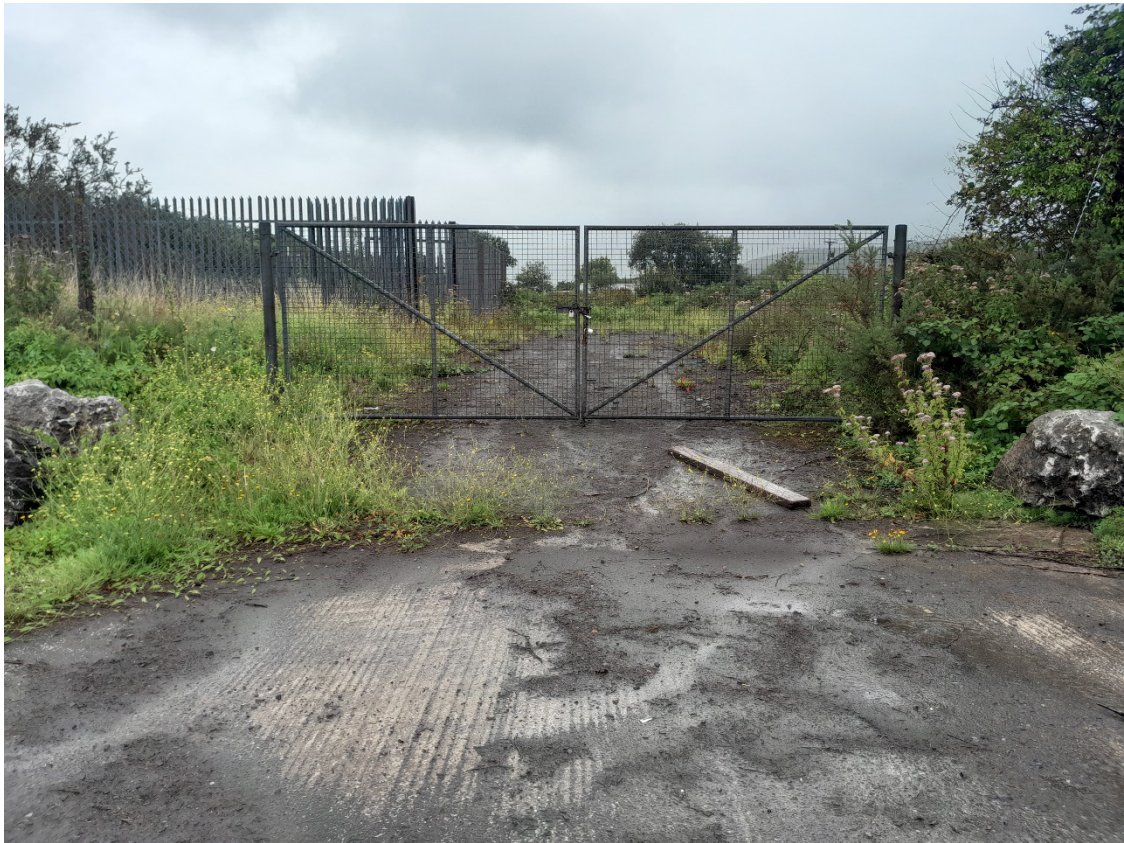
**Image EDP A1.14:** North facing view of the northern end of the Site from the east-west fence line boundary within the Site. The 1990s depicted fenced enclosure is shown on the right, the interior and surrounding land is predominantly overgrown with vegetation. No standing structures were identified on-site within the northern end of the Site.

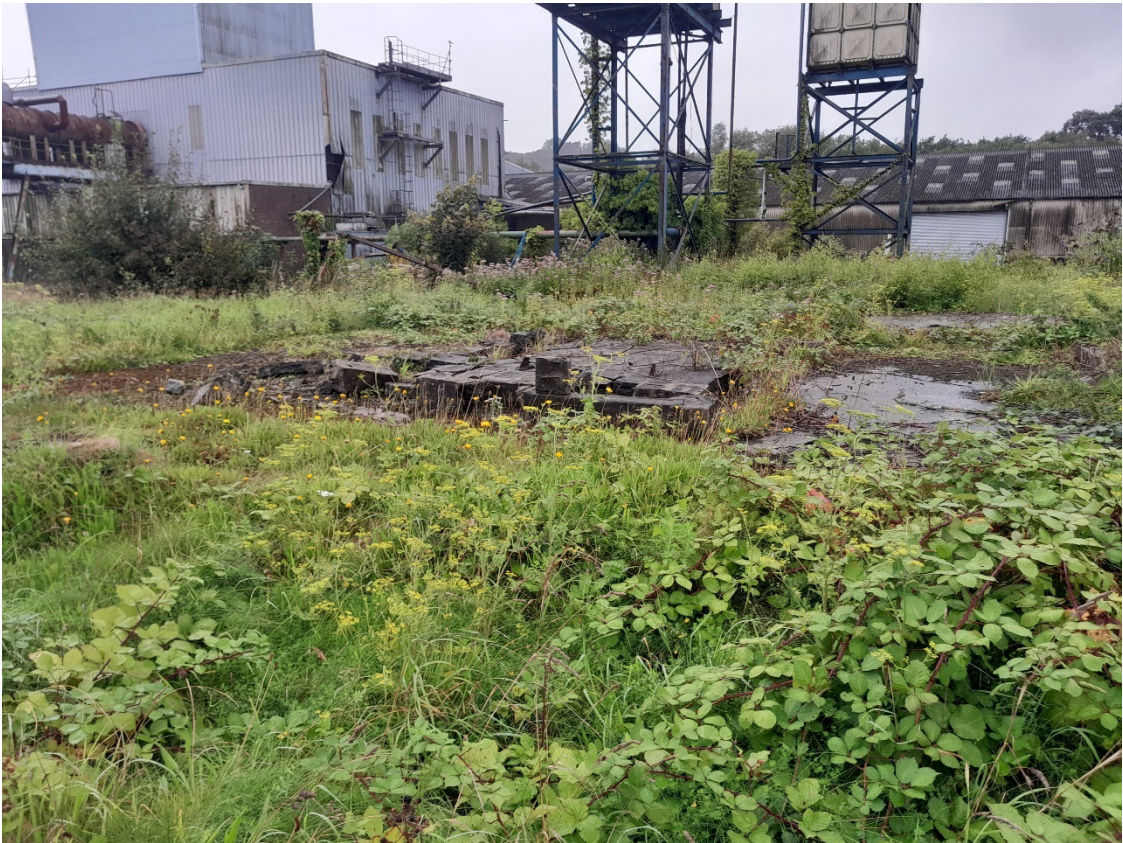
**Image EDP A1.15:** West facing view of latter 20<sup>th</sup> century tank/outbuilding platforms to the east of the Site's building complex.

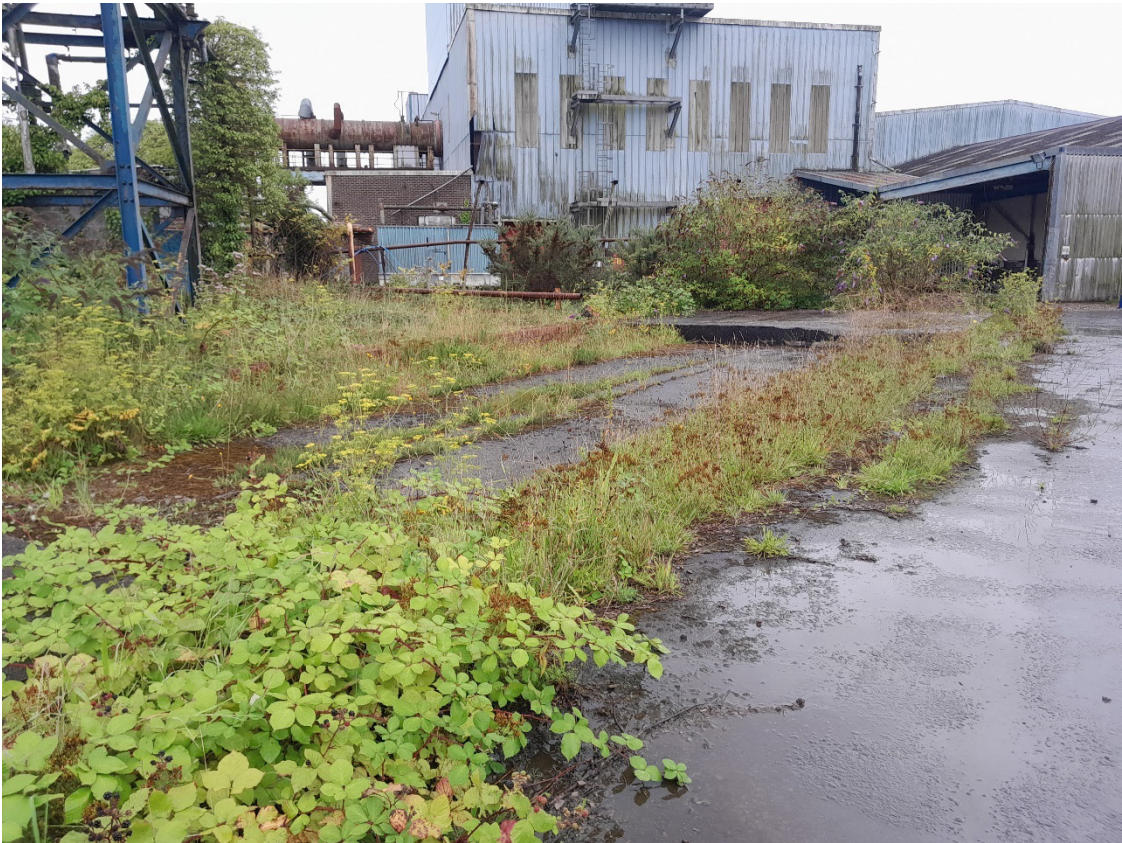
**Image EDP A1.16:** South facing view of tank platforms to the north of the Site's building complex.

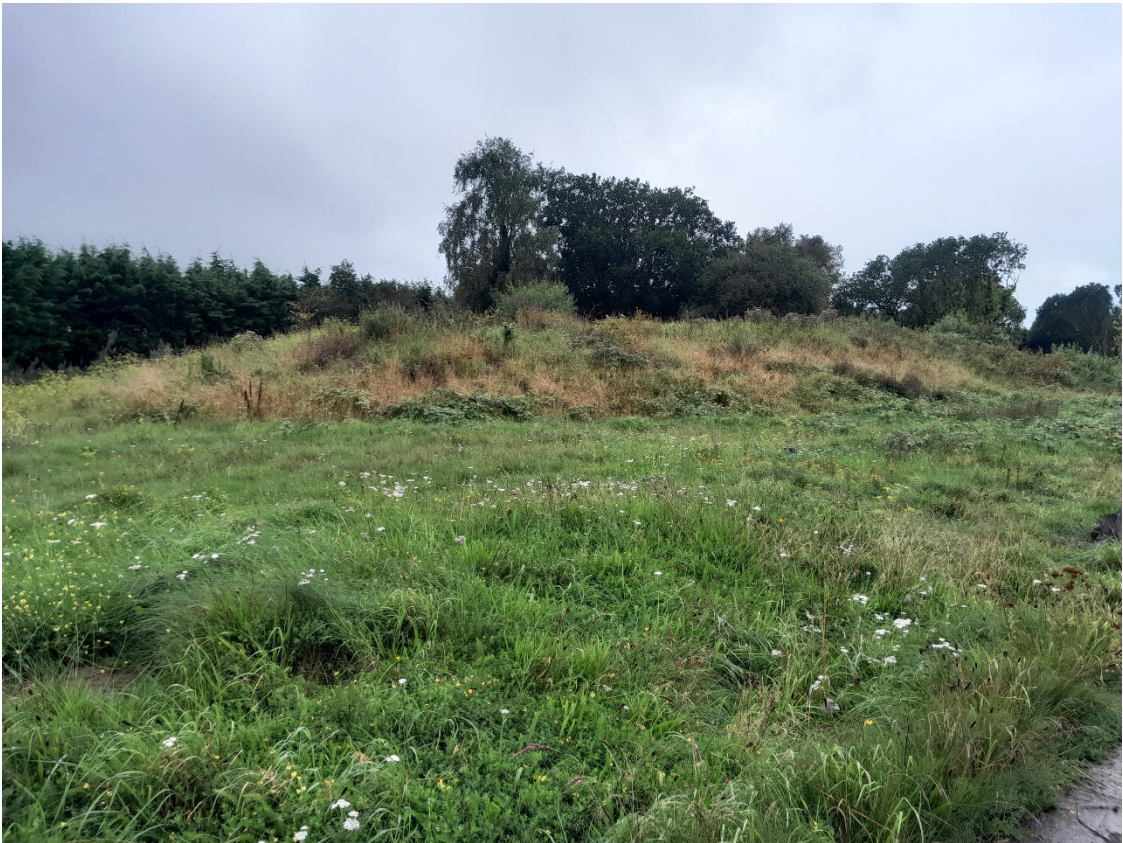
**Image EDP A1.17:** South-east facing view of the identified southernmost spoil heap on Site. Spoil heap runs north-south along the east side of the Site, from the north end of the extant c. 1901 stone boundary while on-site.

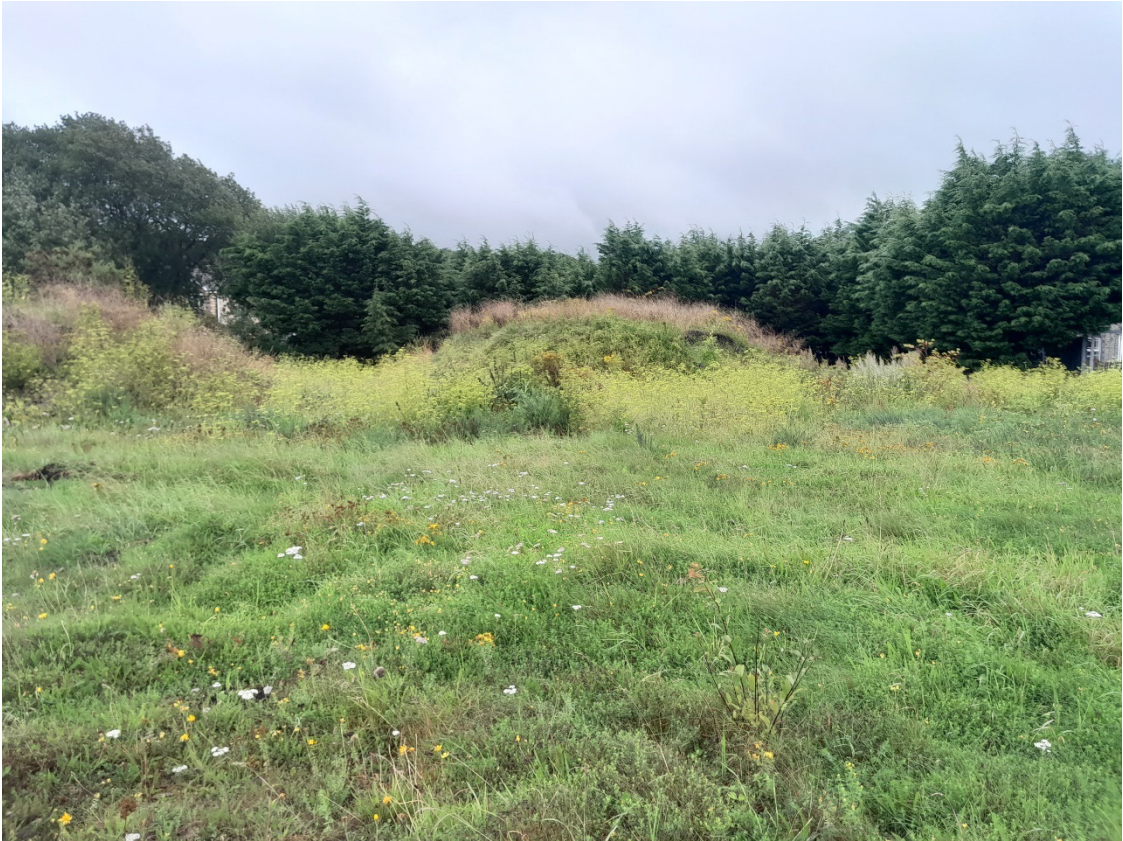
**Image EDP A1.18:** East facing view of the two spoil heaps between the two east entrances of Woodville Road to the Site.

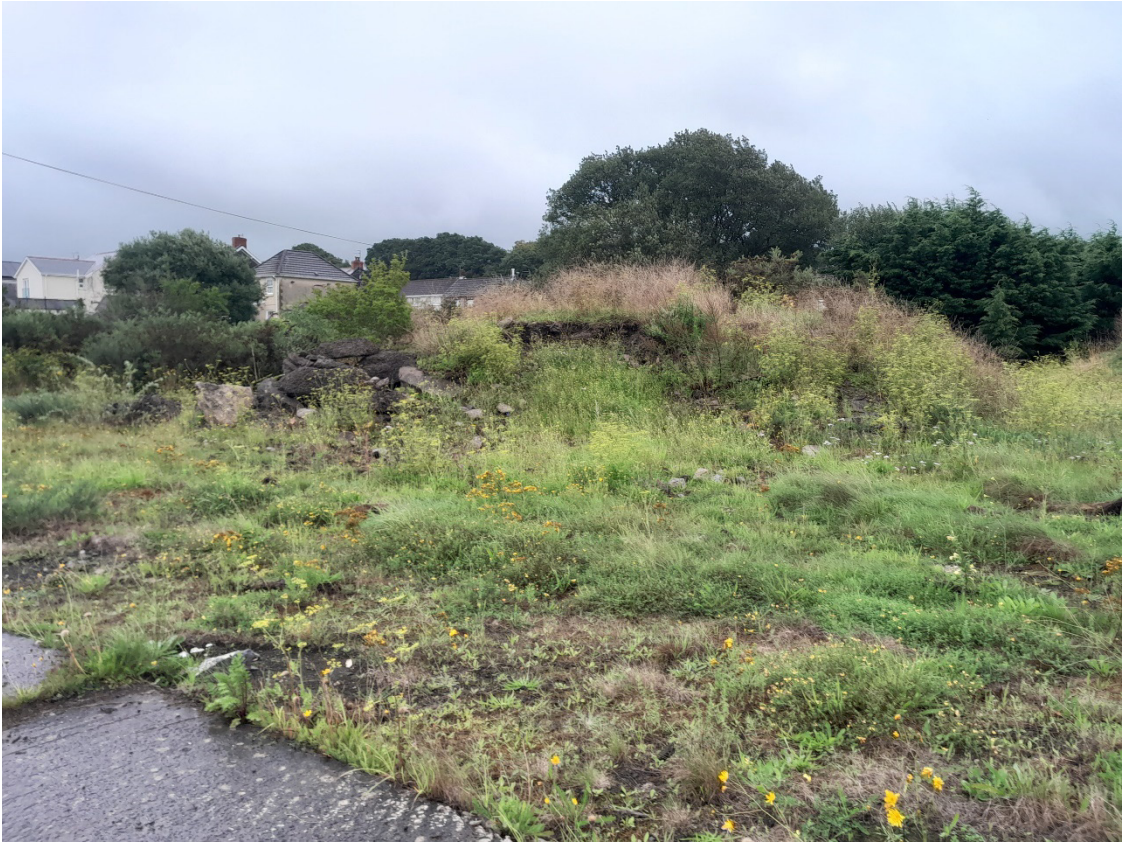
**Image EDP A1.19:** East facing view of the two spoil heaps between the two east entrances of Woodville Road to the Site.

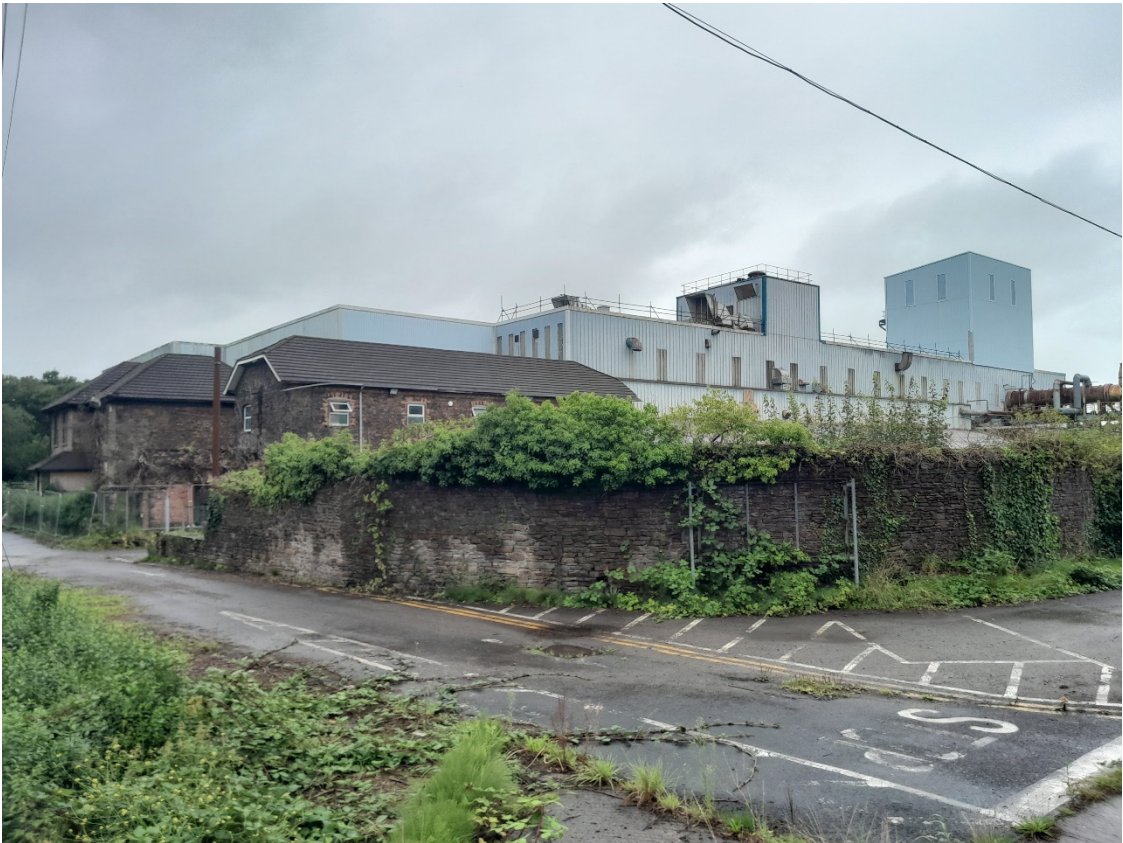
**Image EDP A1.20:** North-west facing view of the identified c. 1901 east stone boundary wall to the former Glamorgan Works (**GGAT01225w**).

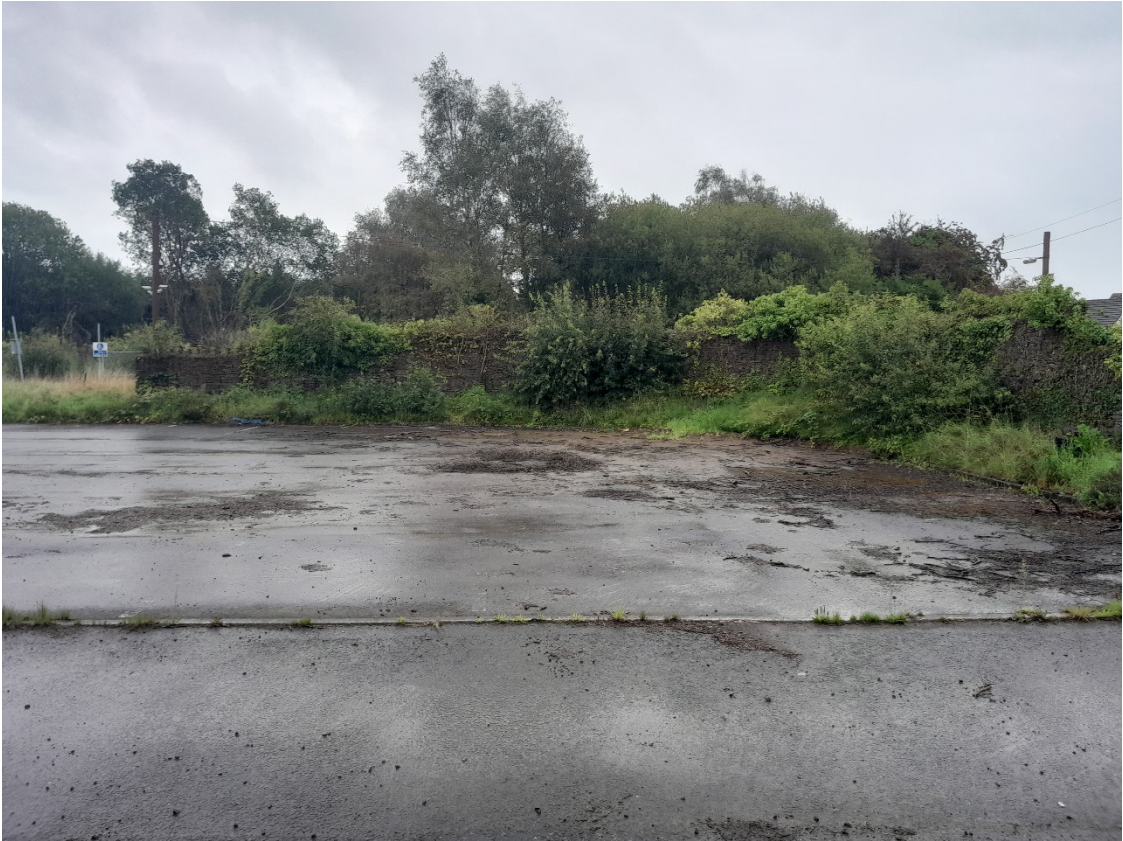
**Image EDP A1.21:** East facing view of the identified c. 1901 east stone boundary wall to the former Glamorgan Works (**GGAT01225w**).

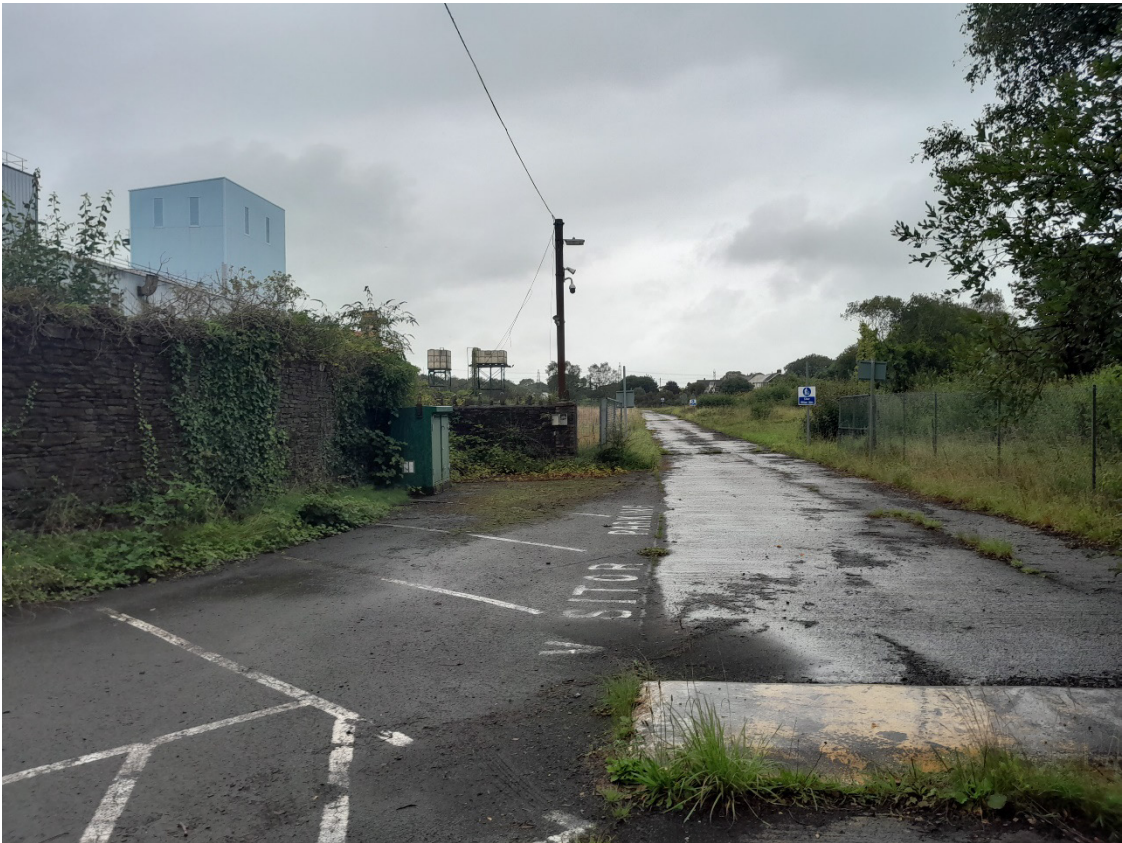
**Image EDP A1.22:** North facing view of the identified c. 1901 east stone boundary wall to the former Glamorgan Works (**GGAT01225w**). The modern, late 1990s north-south haul road is shown to run through the alignment of the stone wall (right side of image).

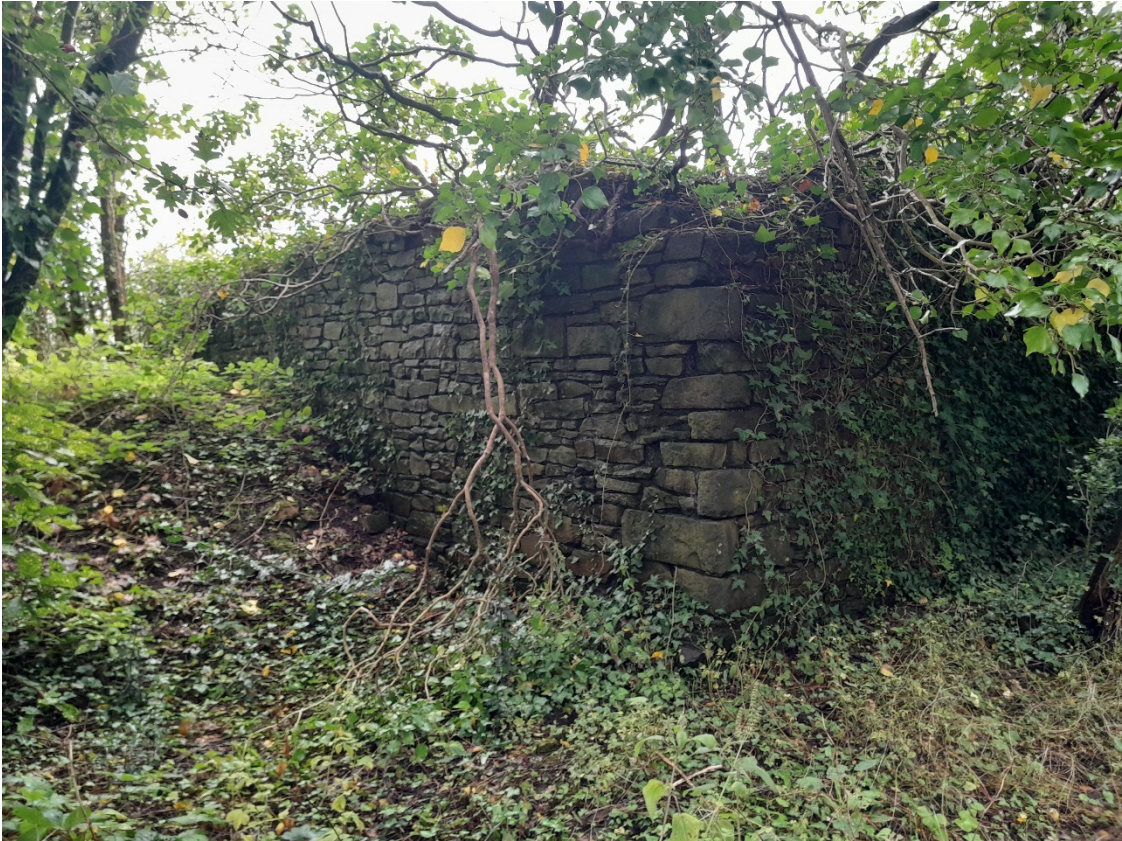
**Image EDP A1.23:** North-west facing view of the identified overgrown corner of the c. 1901 east stone boundary wall to the Glamorgan Works (**GGAT01225w**). The segment of wall is located to the east of the late 1990s north-south haul road through the Site, hidden by vegetation cover.

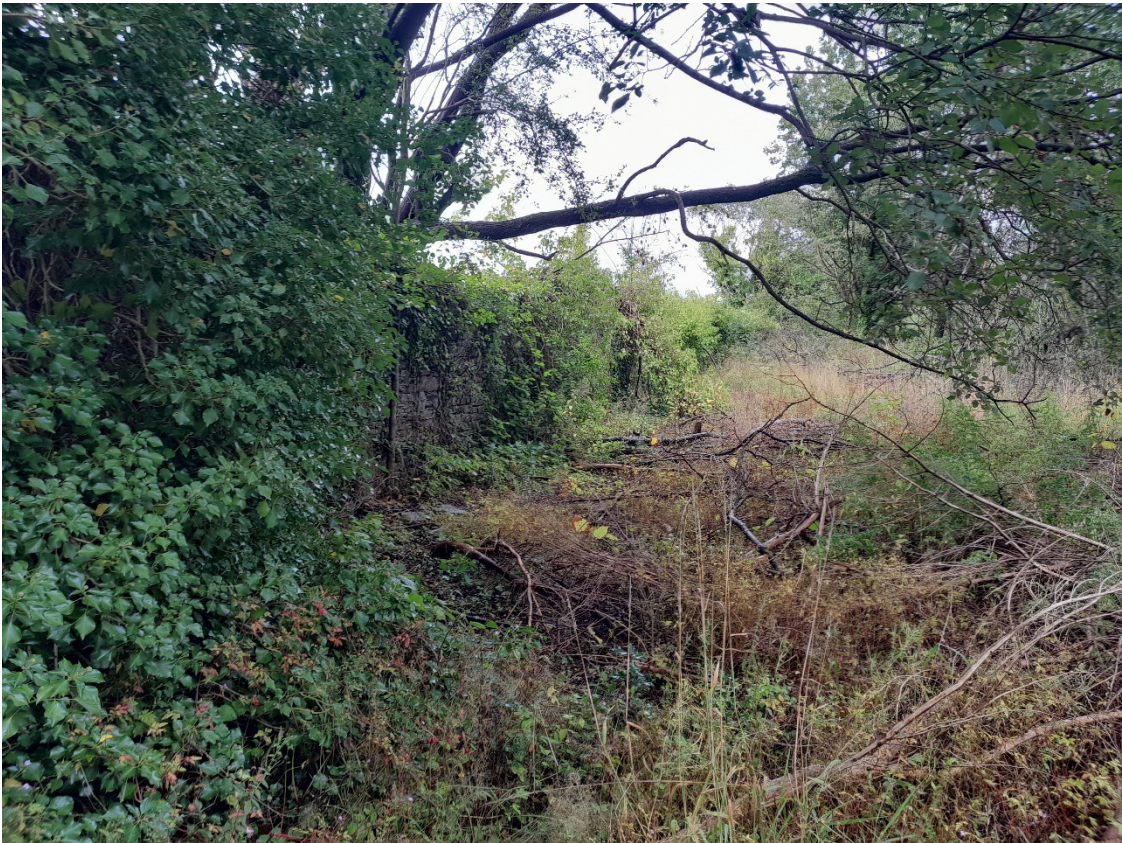
**Image EDP A1.24:** North facing view of the identified overgrown length of the c. 1901 east stone boundary wall to the Glamorgan Works (**GGAT01225w**). The segment of wall is located to the east of the late 1990s north-south haul road through the Site, hidden by vegetation cover.

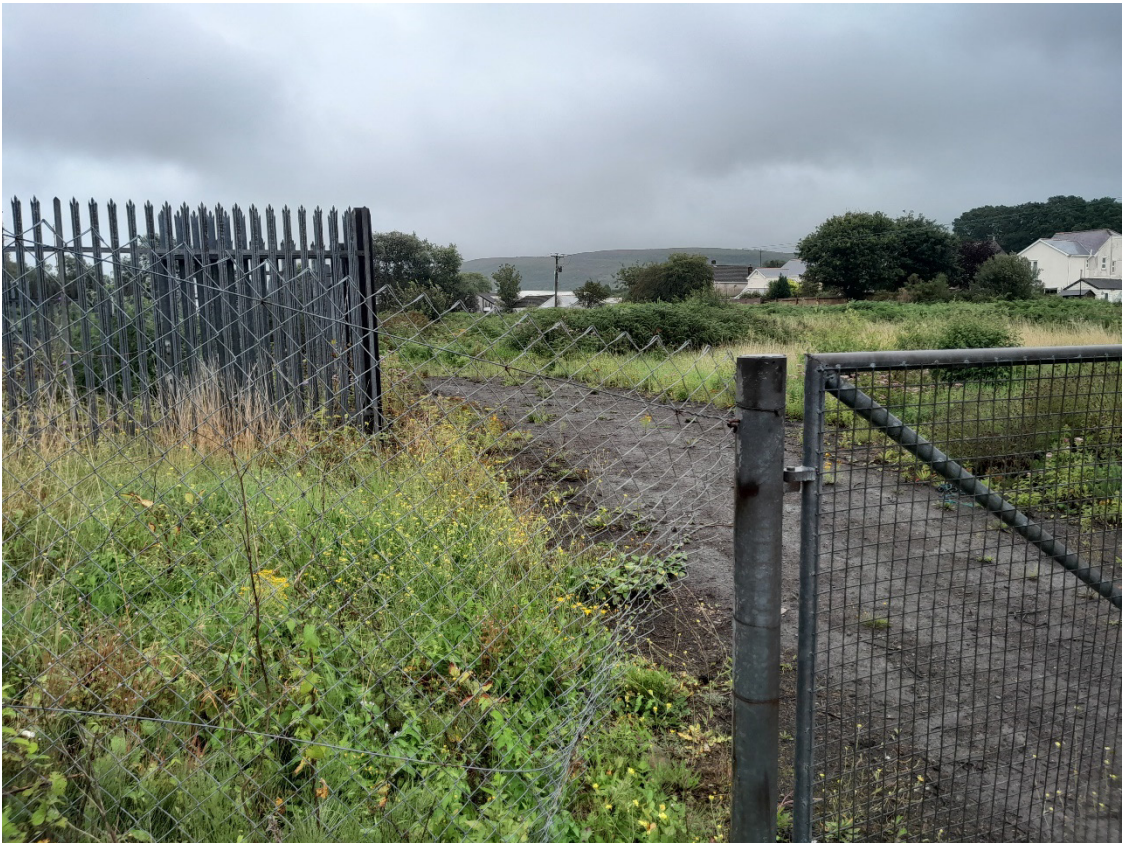
**Image EDP A1.25:** North-east facing view of the north end of the Site. Image to show the overgrown nature of the north end of the Site.
