**FORMER TATA STEEL SITE, HIGH STREET,  
PONTARDDULAIS**

**Site Investigation & Proposed  
Remediation/Reclamation Strategy Report**

14180/FG/23/SI/RevA

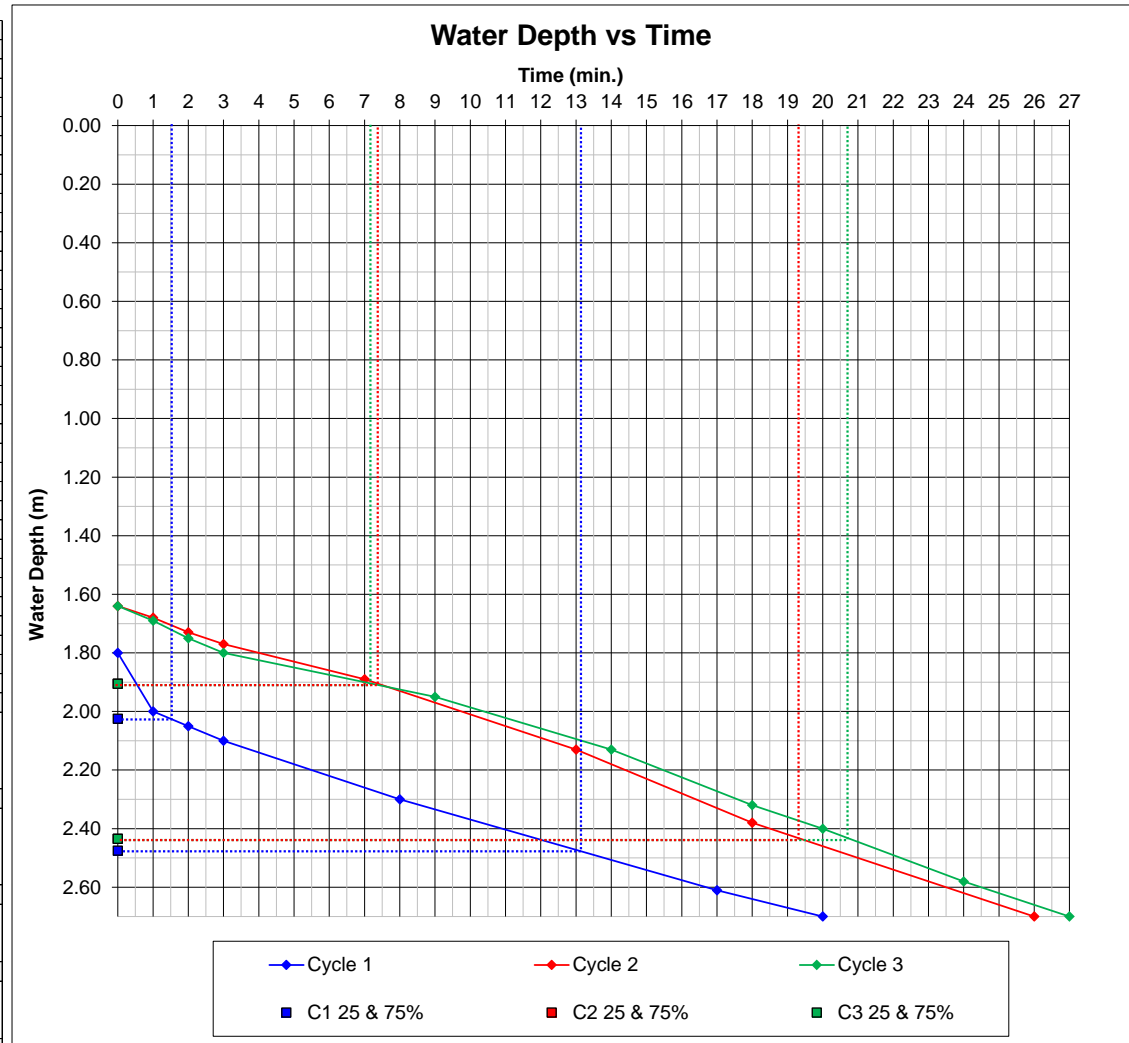
Over measured depth	8.46	9.58	9.58
<b>Soil Infiltration Rate (m/s)</b>			
Over 100% effective depth	1.9E-04	1.5E-04	1.5E-04
Over measured depth	1.9E-04	1.5E-04	1.5E-04
Over 75% - 25% effective depth	<b>2.69E-04</b>	<b>2.71E-04</b>	<b>2.83E-04</b>

Design Soil Infiltration Rate: 2.6E-04 m/s

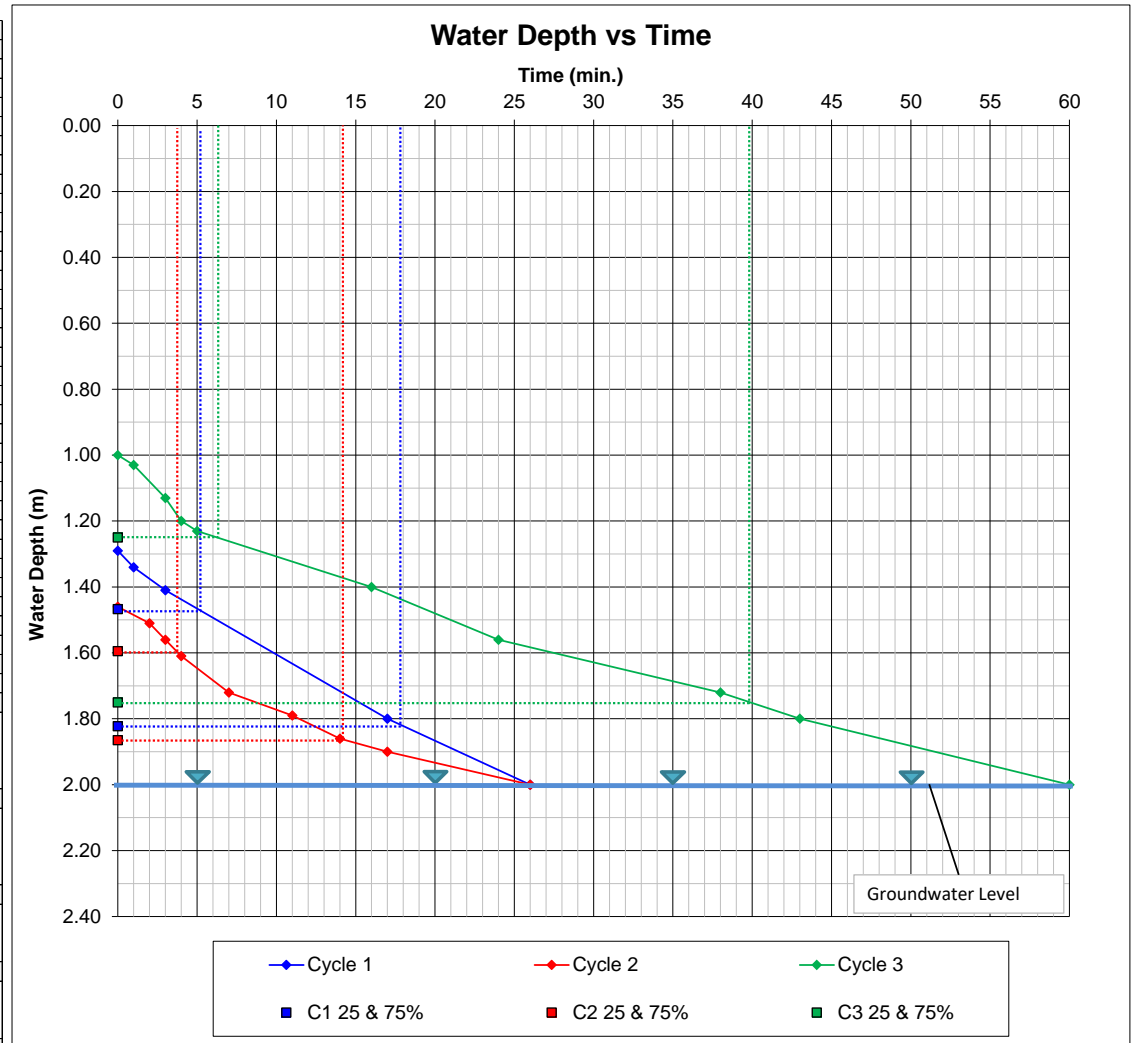
Cycle 1		Cycle 2		Cycle 3	
Time (min)	Depth (m)	Time (min)	Depth (m)	Time (min)	Depth (m)
0	1.29	0	1.46	0	1.00
1	1.34	2	1.51	1	1.03
3	1.41	3	1.56	3	1.13
17	1.80	4	1.61	4	1.20
26	2.00	7	1.72	5	1.23
		11	1.79	16	1.40
		14	1.86	24	1.56
		17	1.90	38	1.72
		26	2.00	43	1.80
				60	2.00

Design Soil Infiltration Rate: 7.5E-05 m/s

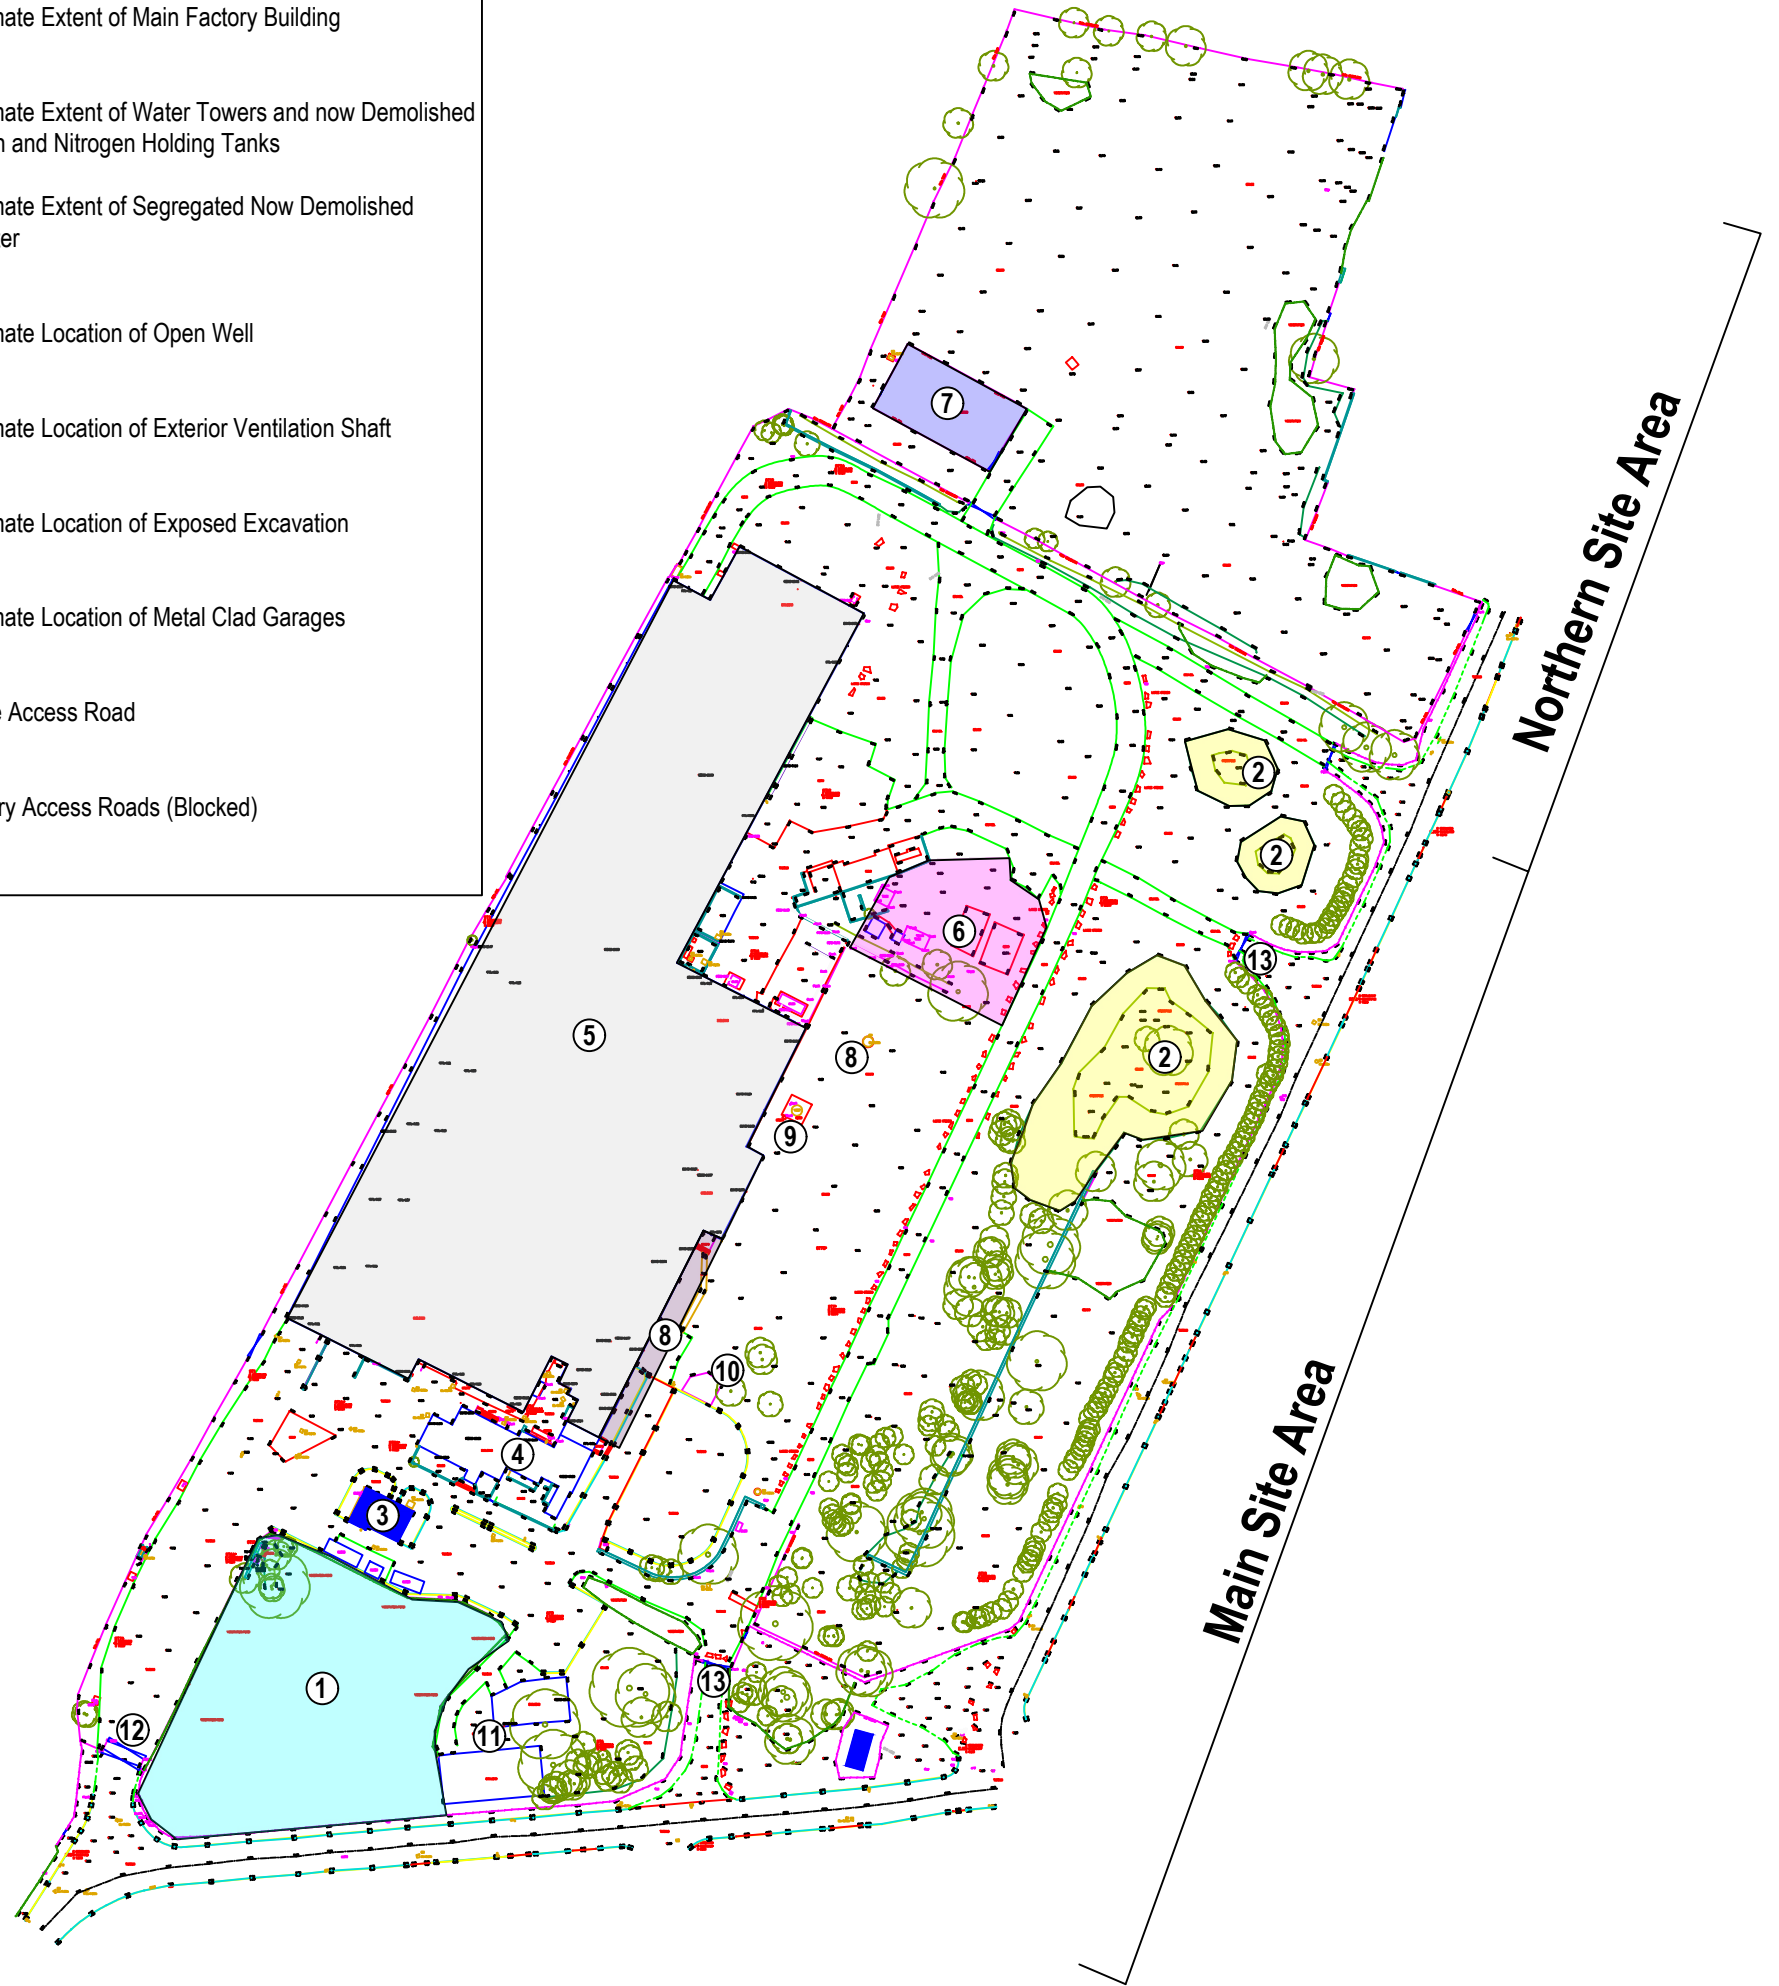
Figure 2: Existing Site Layout

- ① Approximate Extent of Segregated Pond Area
- ② Approximate Location of Historic Stockpiles
- ③ Approximate Location of Foreman Offices
- ④ Approximate Locations of Office Buildings
- ⑤ Approximate Extent of Main Factory Building
- ⑥ Approximate Extent of Water Towers and now Demolished Hydrogen and Nitrogen Holding Tanks
- ⑦ Approximate Extent of Segregated Now Demolished Gasometer
- ⑧ Approximate Location of Open Well
- ⑨ Approximate Location of Exterior Ventilation Shaft
- ⑩ Approximate Location of Exposed Excavation
- ⑪ Approximate Location of Metal Clad Garages
- ⑫ Main Site Access Road
- ⑬ Secondary Access Roads (Blocked)

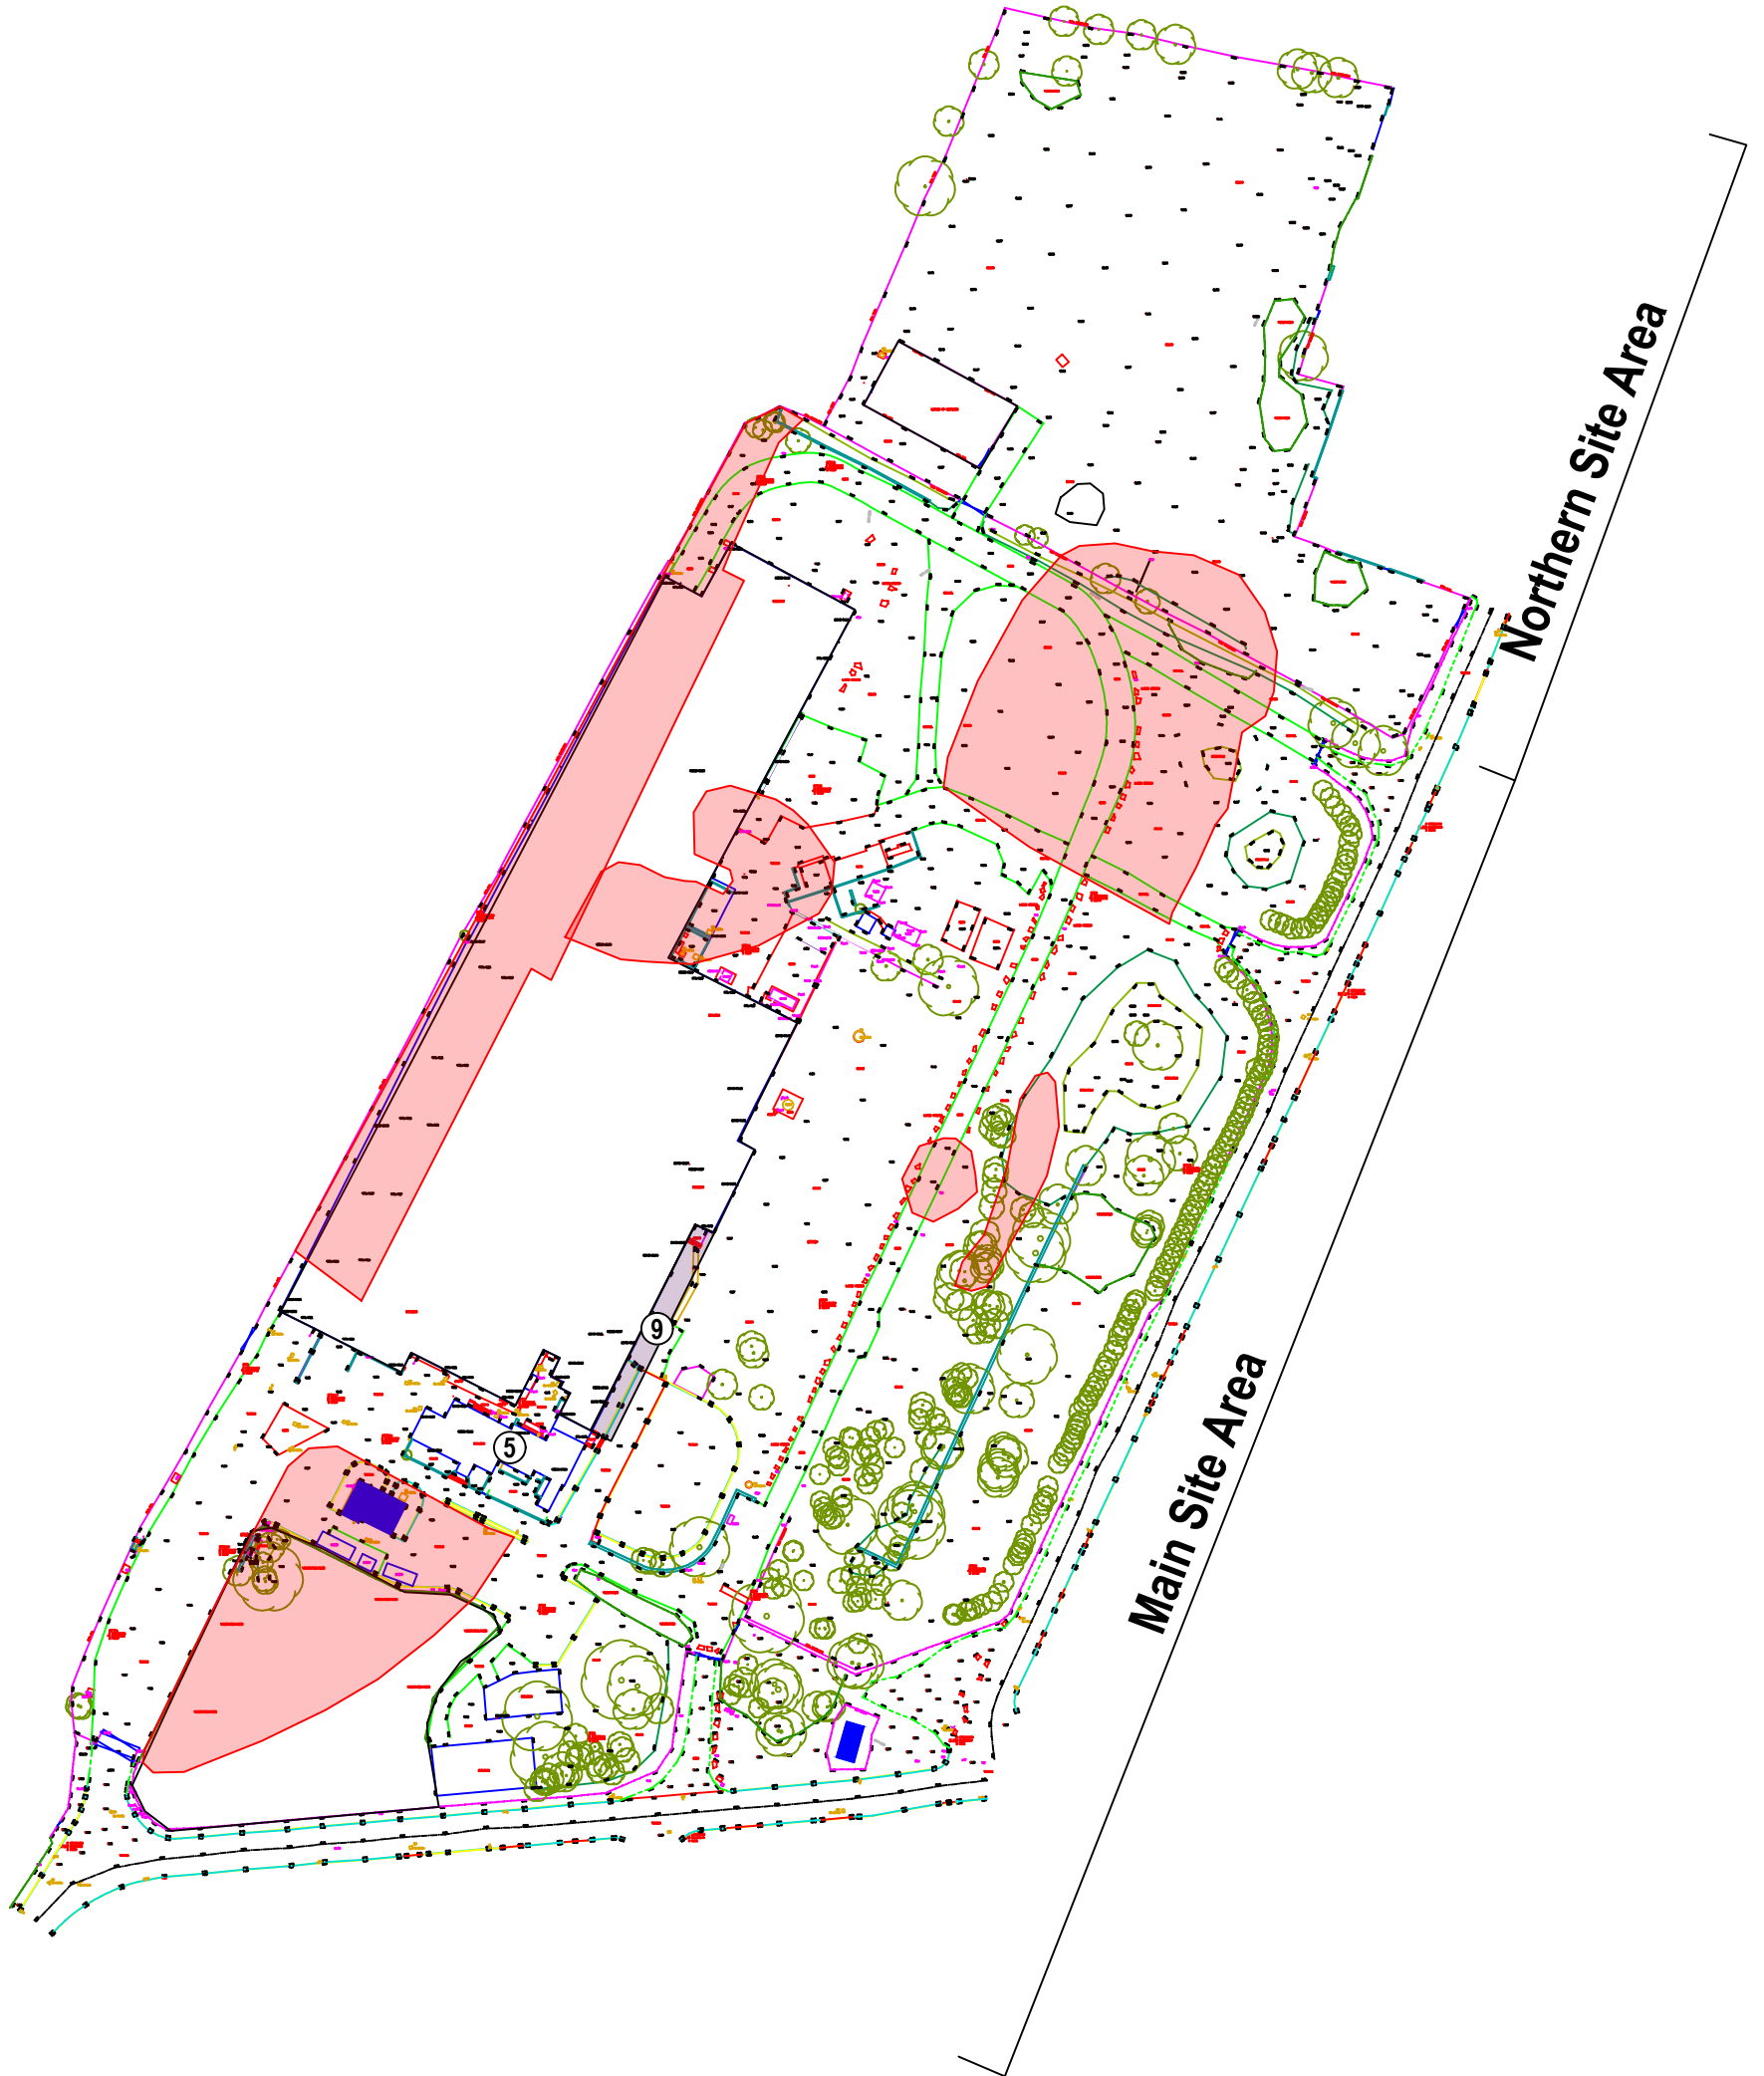
Figure 6: Historical Extraction Pits Locations

Approximate Extent of Historical Extraction Pits (see Envirocheck Report)
